March 13, 2015

RE: Roof Snow Loads
Oyster River High School
Oyster River Cooperative School District
Durham, NH

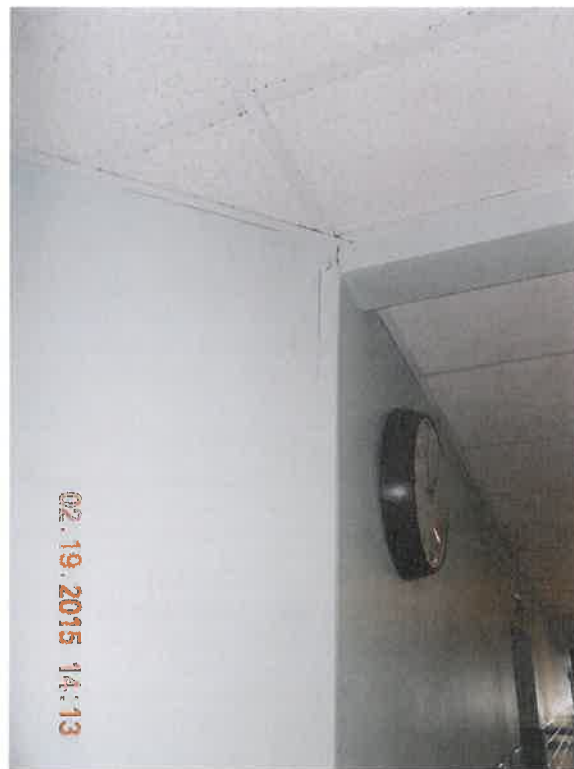
Cracks caused by absence of deflection track

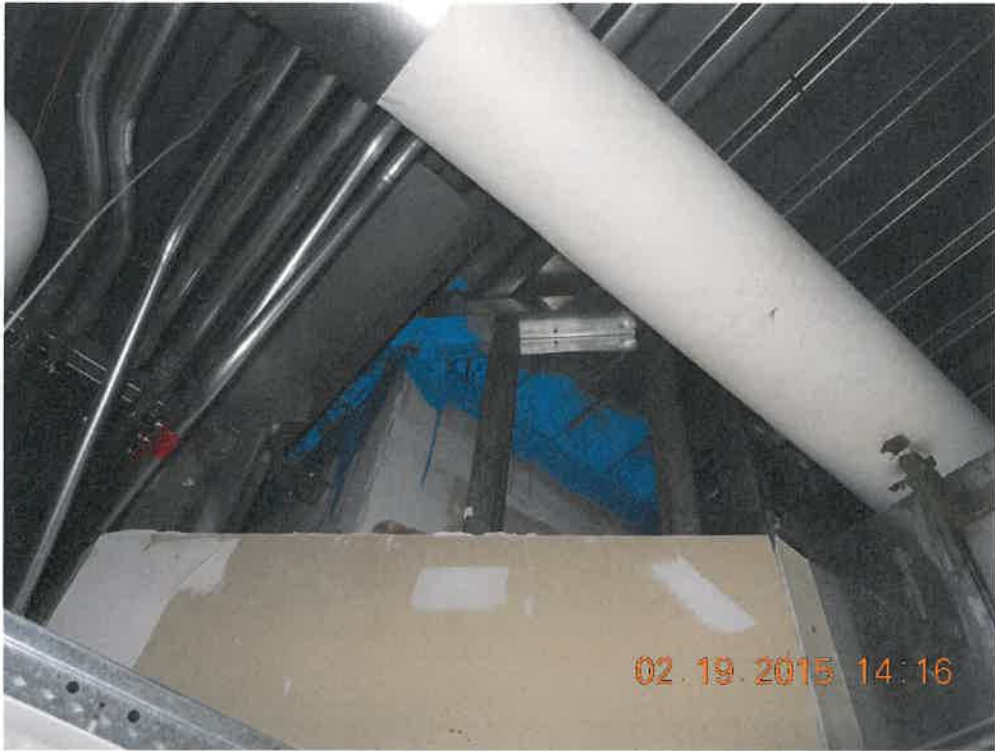
Studs attached directly to roof deck

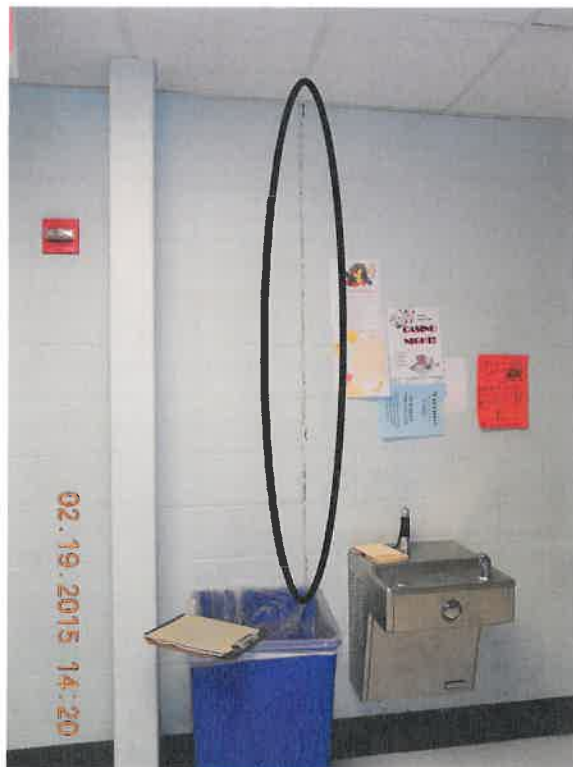
3rd floor corridor - failed control joint due to inadequate thickness of caulking.

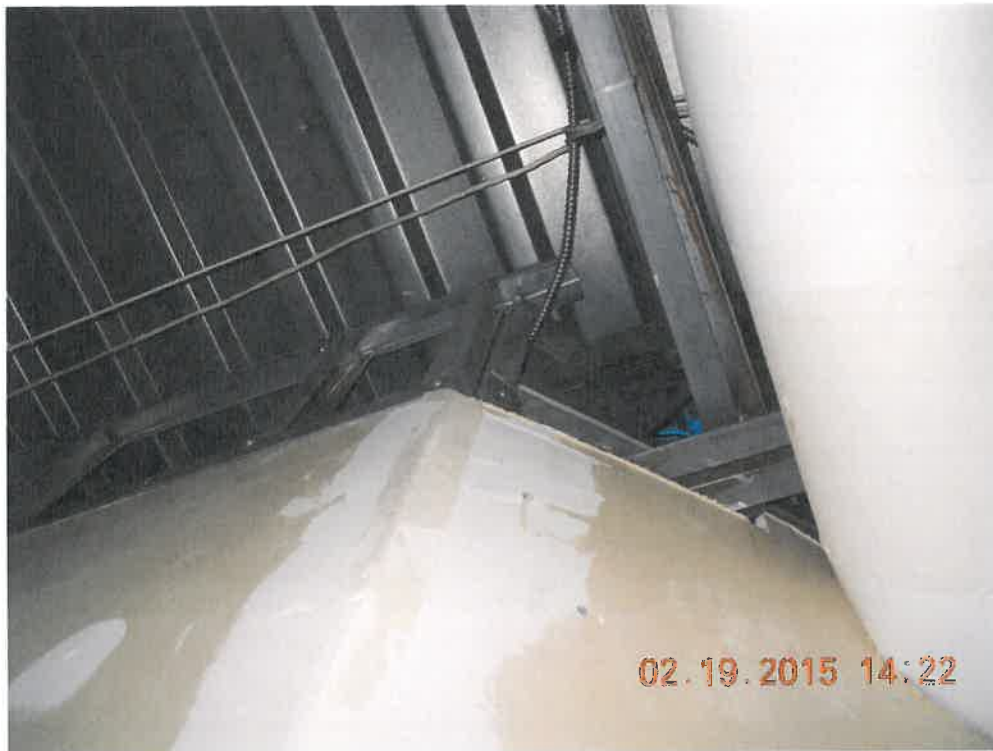
Studs extend to roof deck. No deflection track.

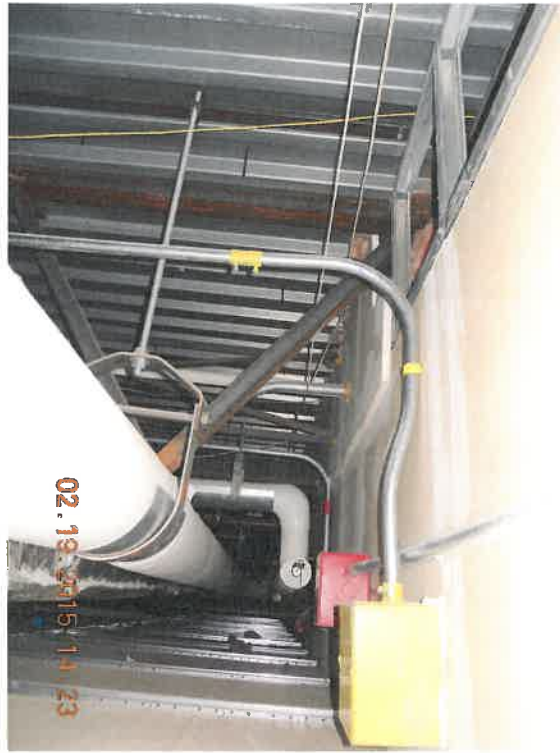
No deflection track in place.

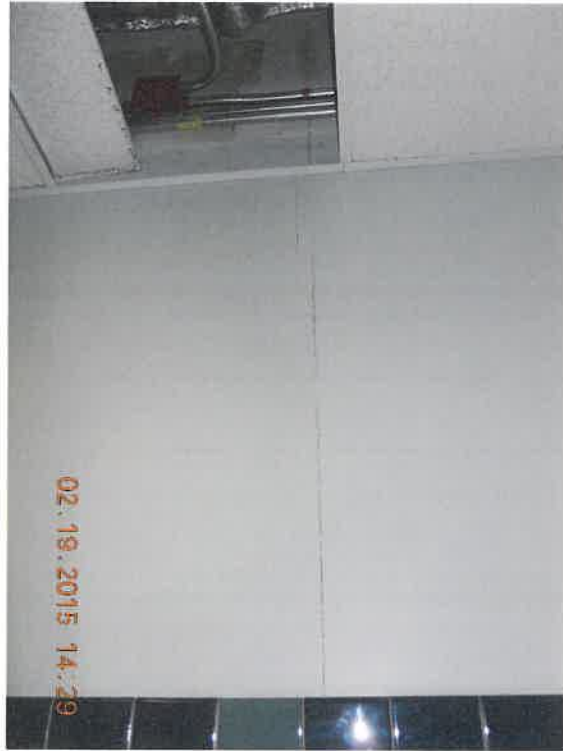
<i>Room:</i>	<i>Observations – Comments:</i>
T-308	Corridor wall was noted to be full height to the roof deck. Full height drywall joint failed. Joint aligns with structural column. Suspect that drywall is not attached properly. No visible signs of structural damage.
T-308	Water damage observed. Checked area above ceiling in the area of the covered bar joist. No visual damage to structural elements was noted, no signs of distress were observed.

Corridor wall near room T308 / T307. Failed drywall joint.

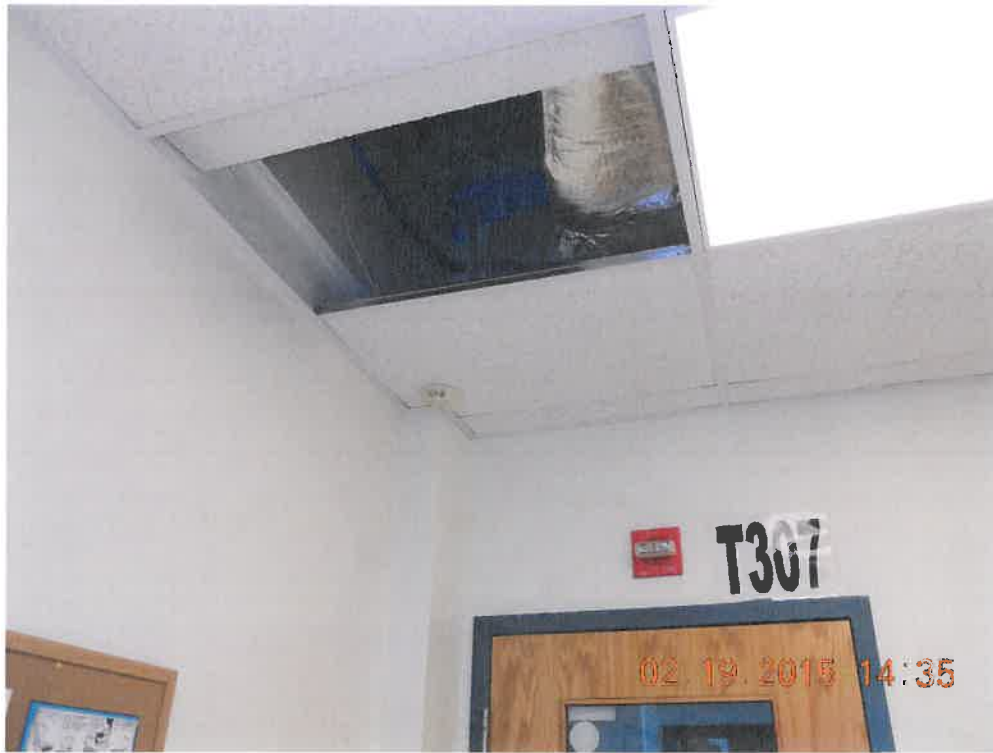
Water damage above ceiling.

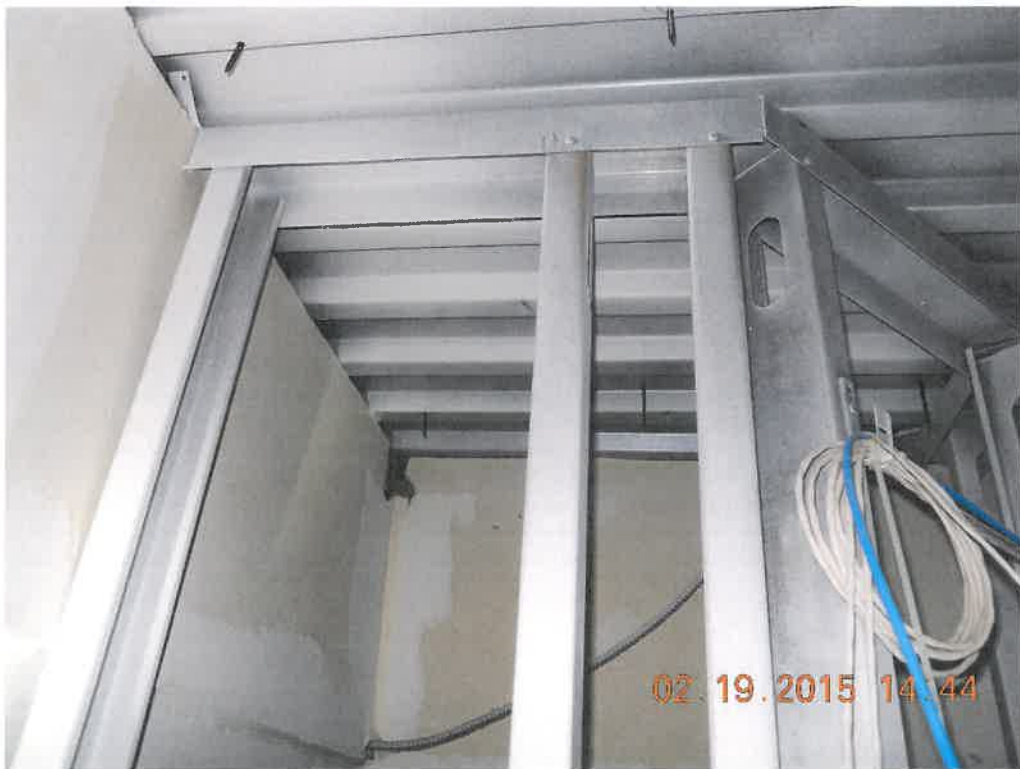
Stud wall attached directly to roof deck.

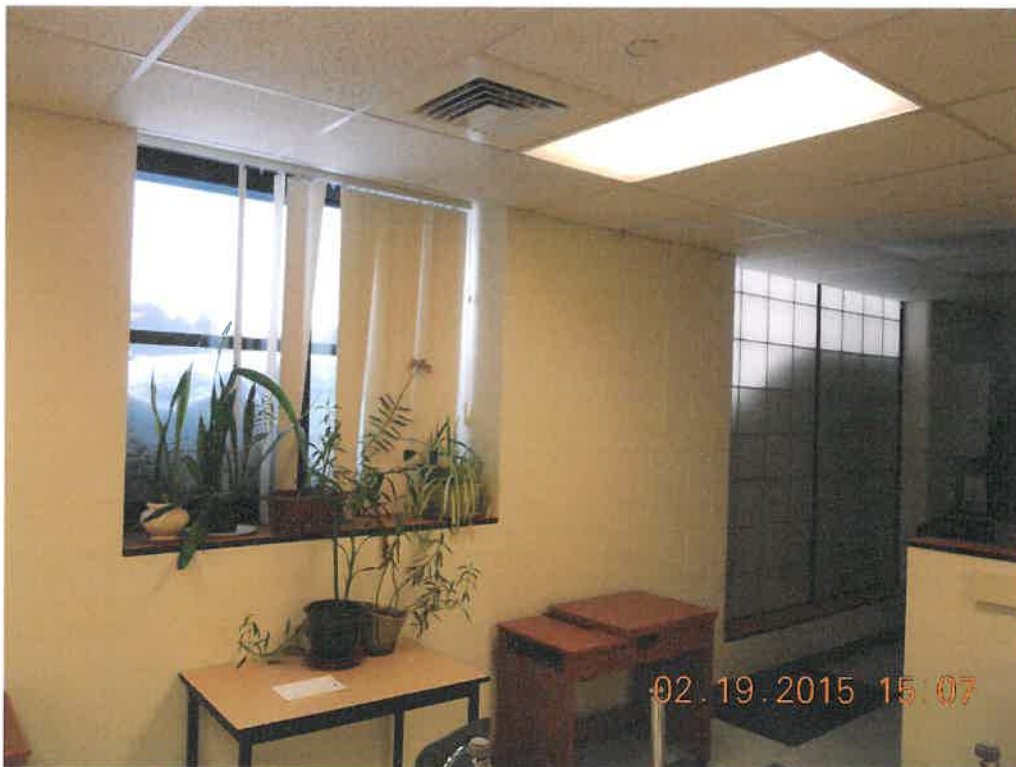
Snow stacked against window & translucent panels.

- Without further additional review, calculations, or inspections, we recommend that snow depths on the high school roof not exceed 24 inches.
- As snow removal crews were working at the time of the field inspection, we recommend that snow removal be continued to remove the excess snow at this time and to prepare for the next winter storm.
- Drywall cracks may be repaired but will reoccur when snow loads occur on the roof unless the light gage metal framing is modified by using proper deflection cracks at the top of wall above the observed cracks.
- All roof drains shall be kept free of snow to allow for snow melt.
- There were no indicators found that exhibited structural damage or distress to structural elements.

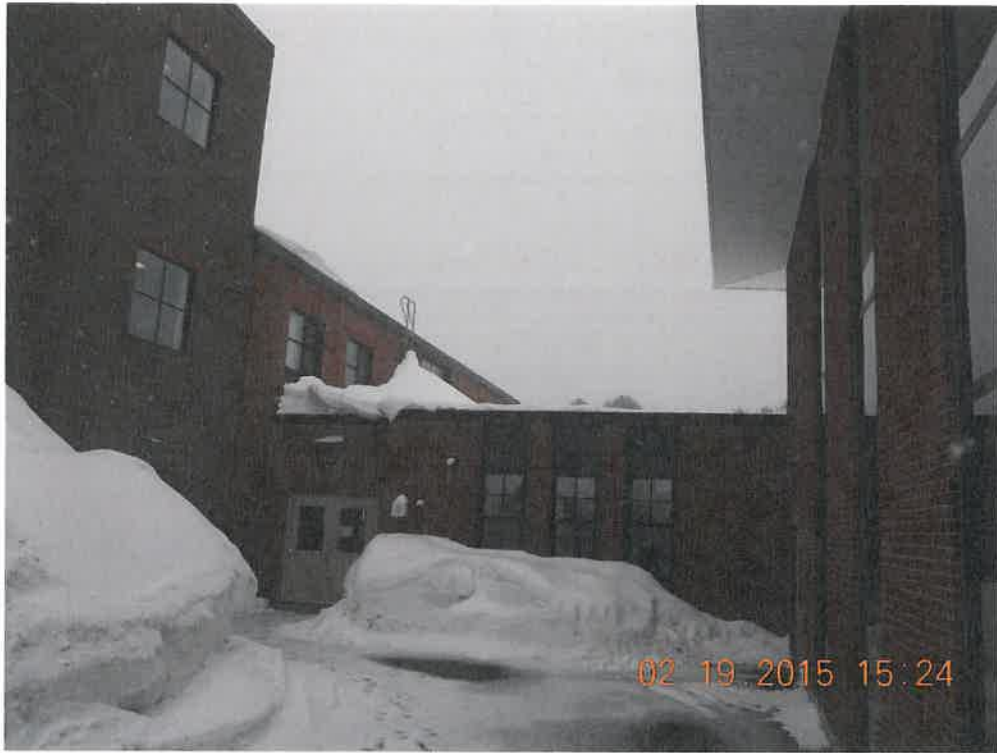
Build up of snow on low roof above corridor
