EMANUEL ENGINEERING, INC.

ENGINEERING CONSULTANTS

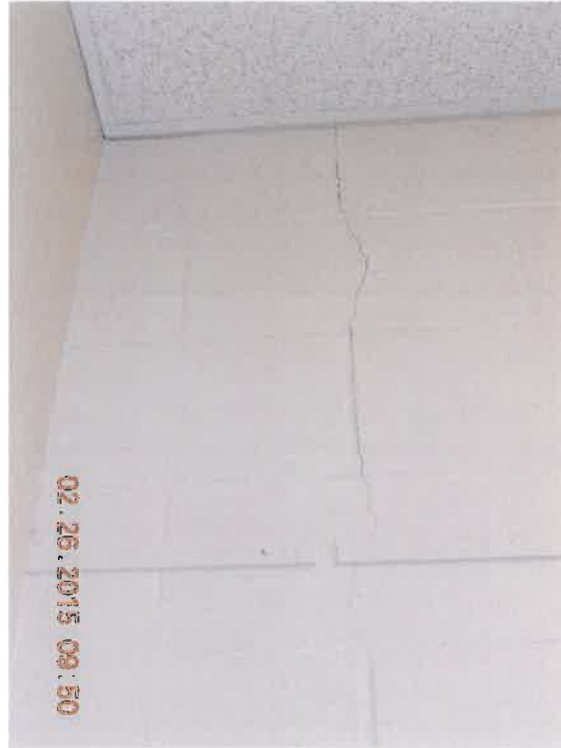
**Room 5 - vertical crack indicative of shrinkage /
contraction of exterior wall**

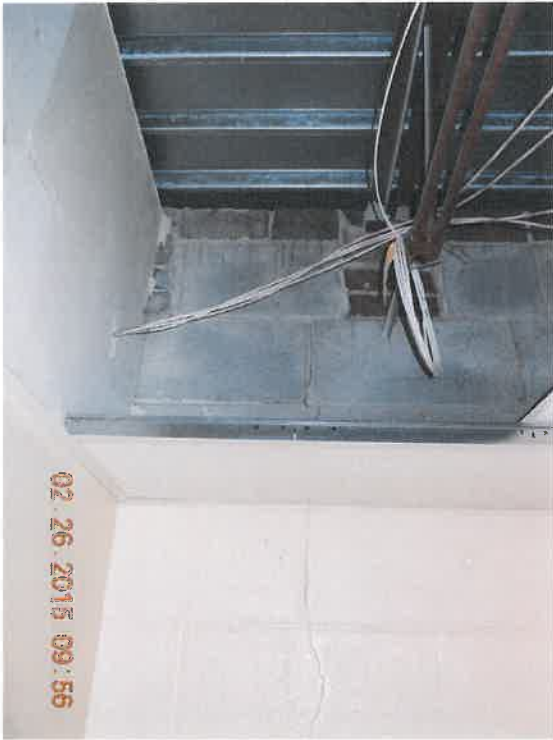
Room 5 - crack extends to point of support

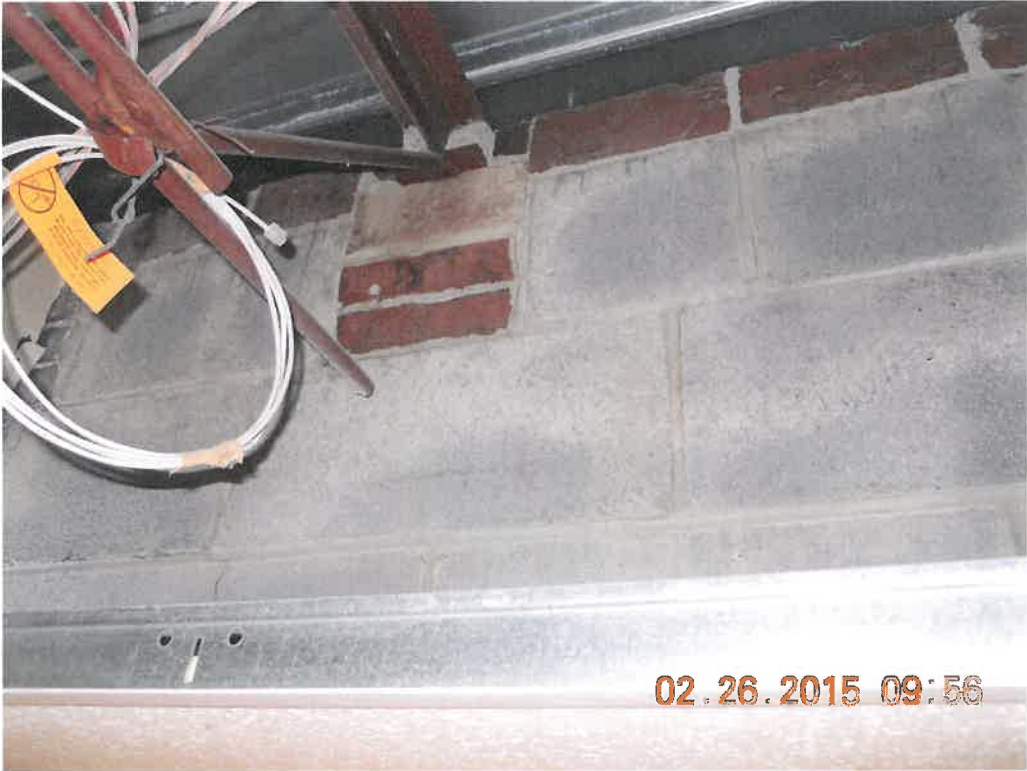
Room 5 - no structural roof damage

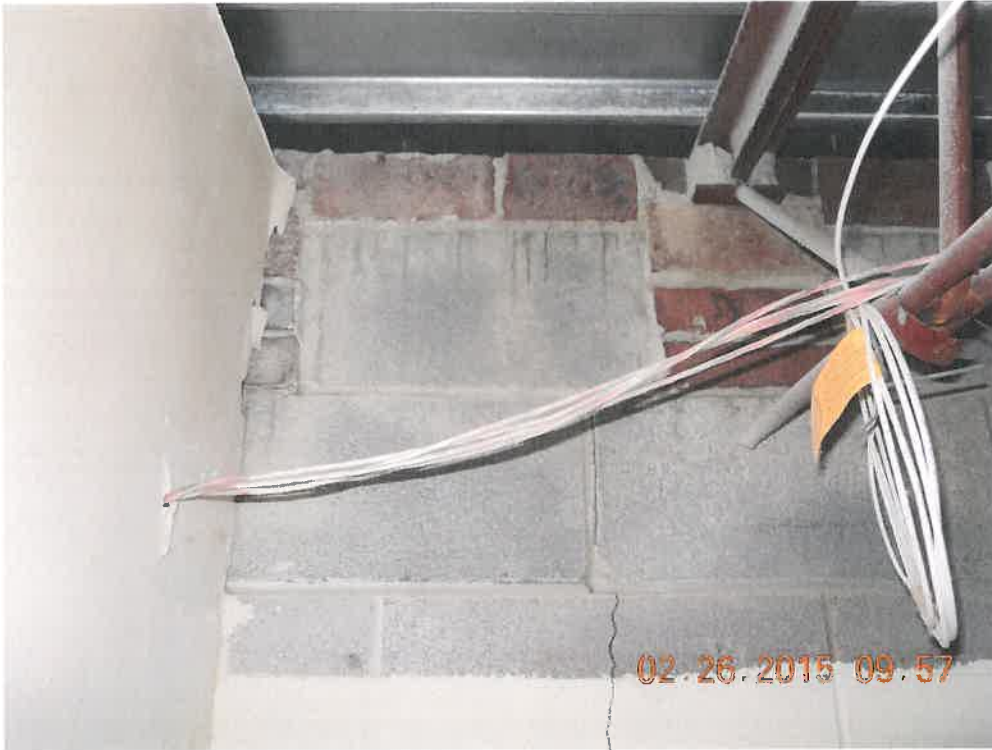
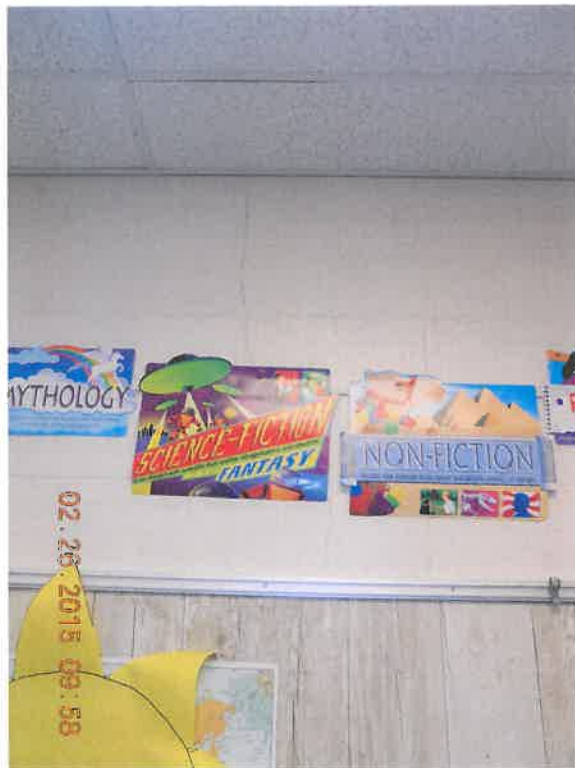
Room 5 - exterior wall crack #2

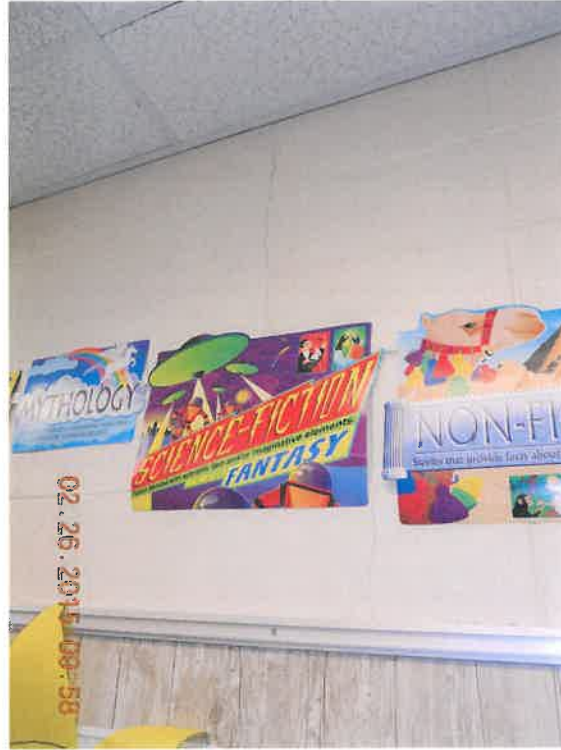
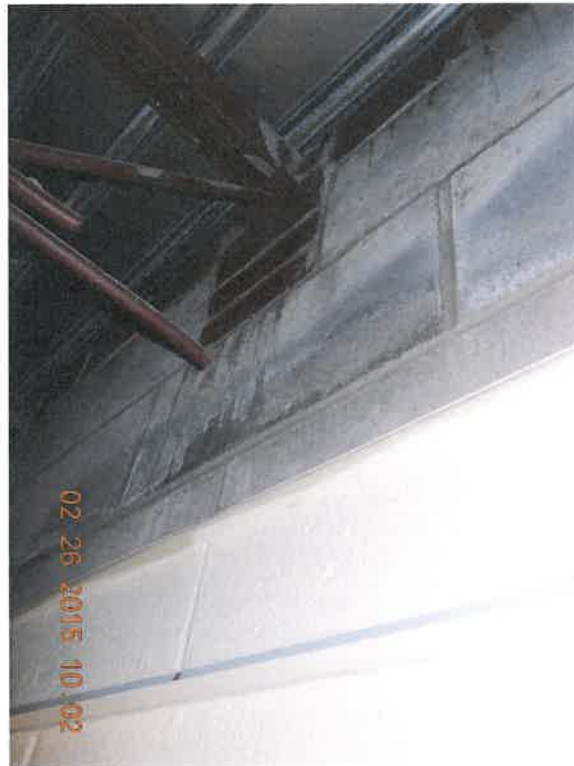
Room 5 - no roof damage

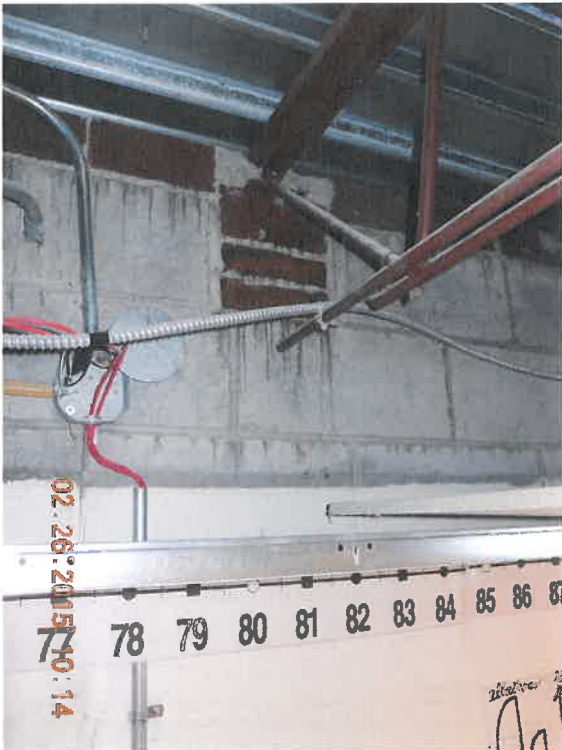
Room 7 - no structural damage observed

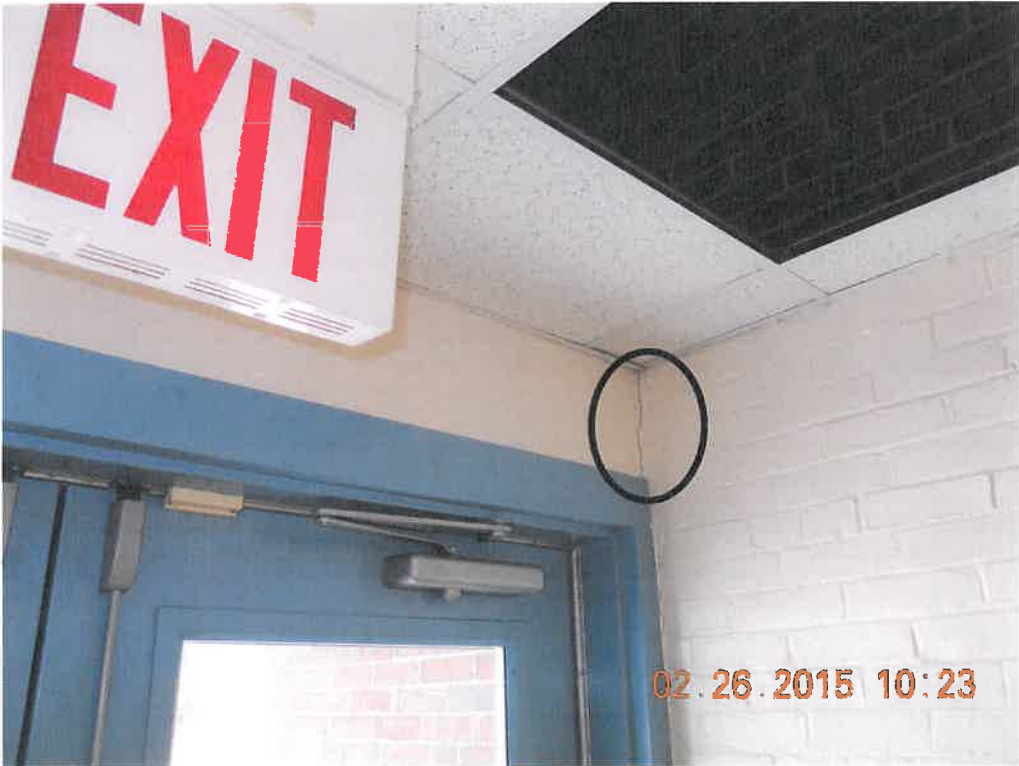
Corridor wall crack at exit door

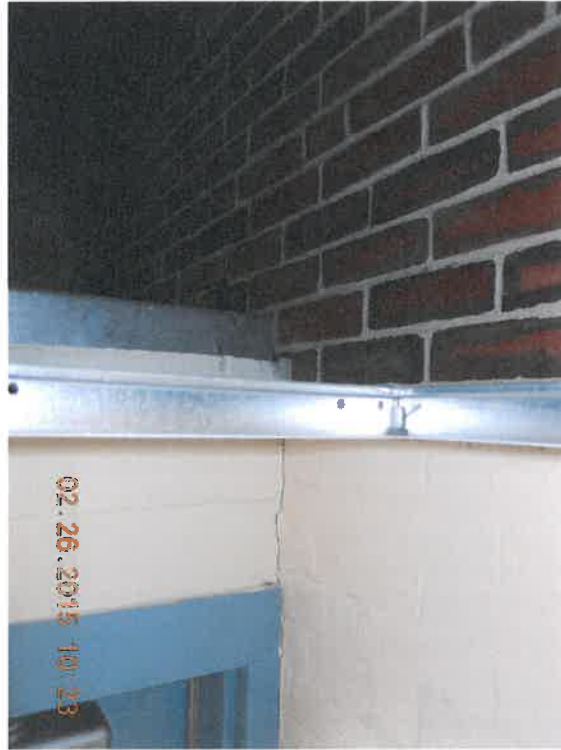
Corridor wall crack at exit door and above ceiling

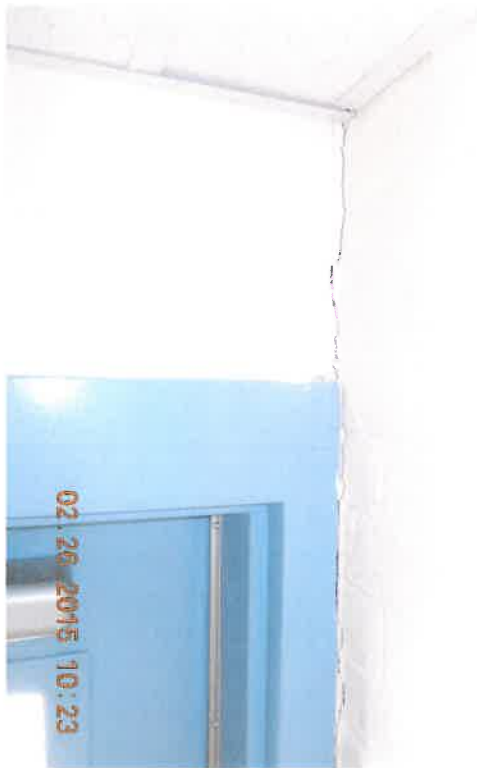
Natural shrinkage. New wall meets old.

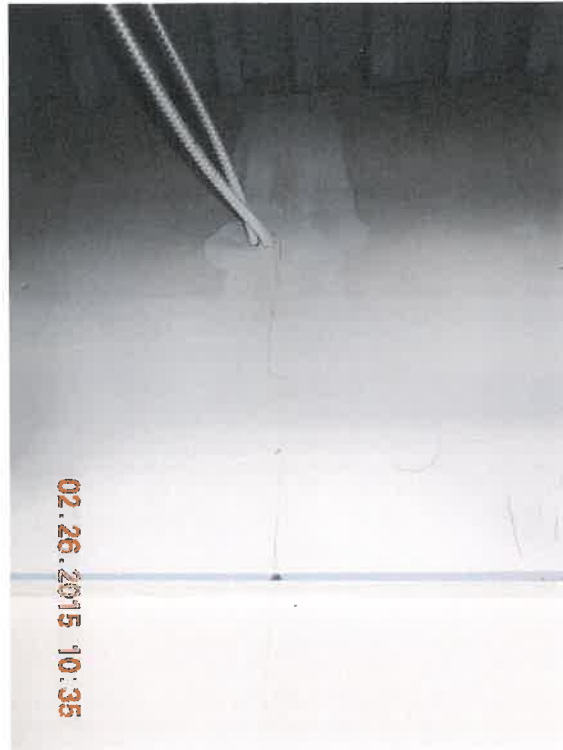
Wall attaches to roof deck

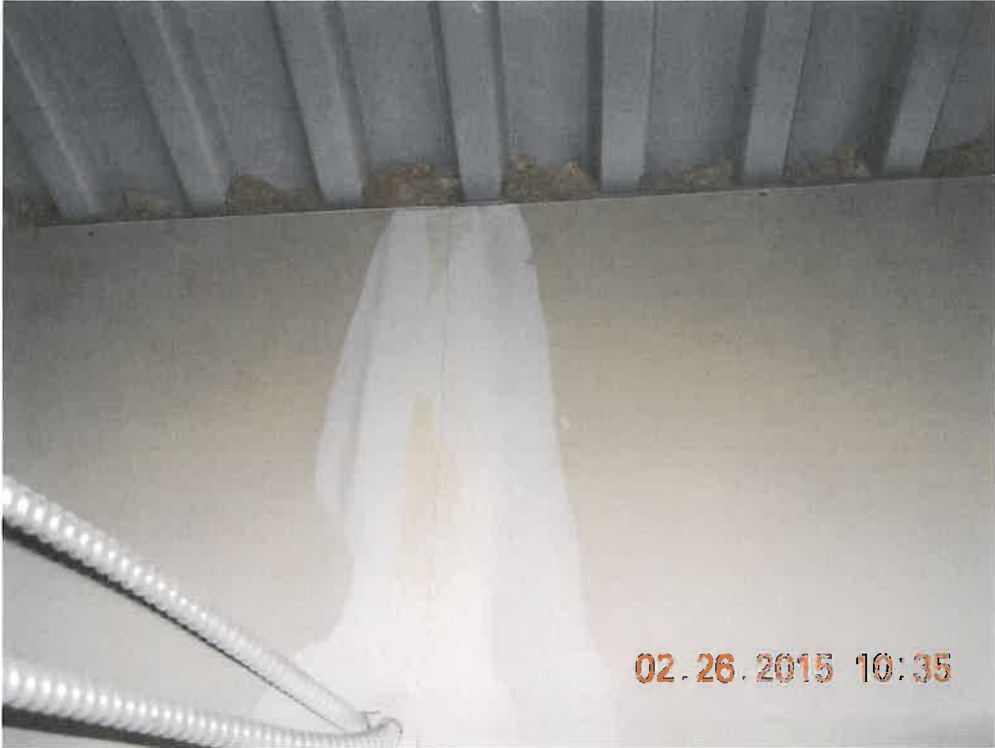
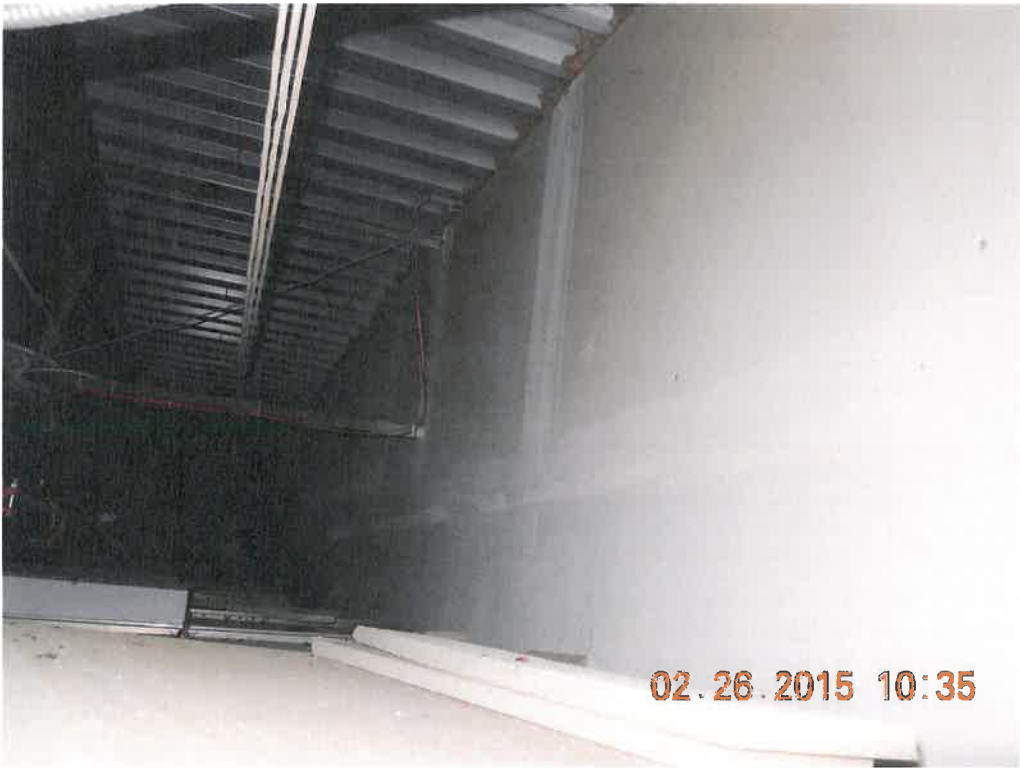
No signs of structural damage
