# EMANUEL ENGINEERING, INC.

March 13, 2015

RE: Roof Snow Loads  
Middle School  
Oyster River Cooperative School District  
Durham, NH

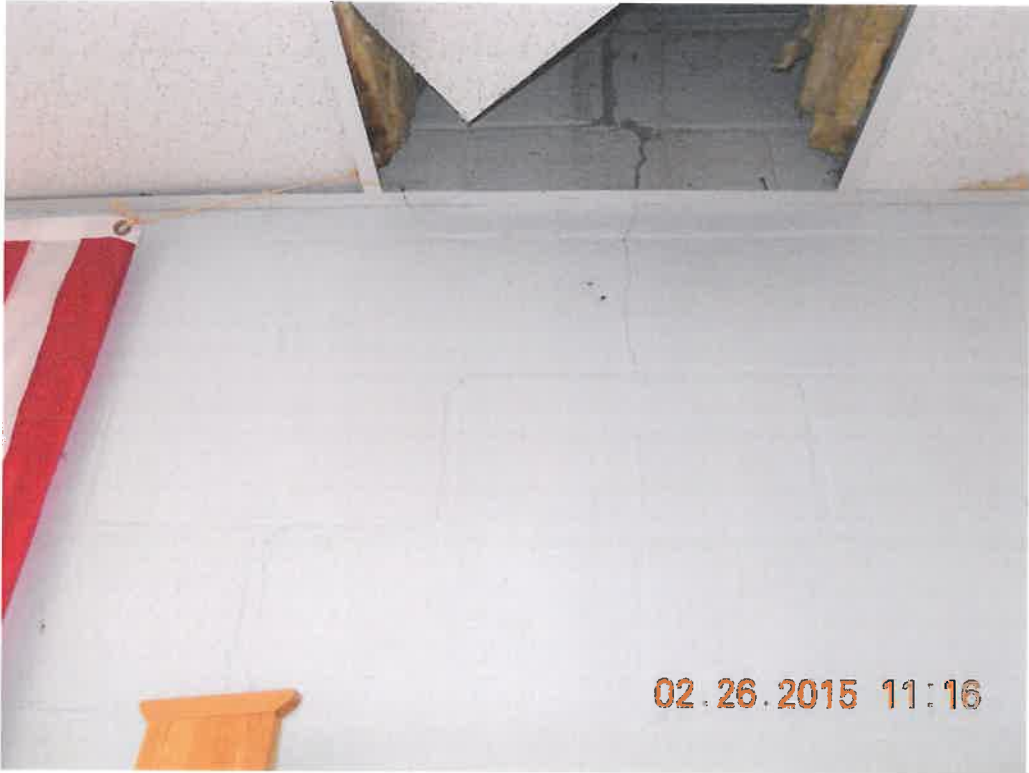
**Old crack noted by mortar repair**

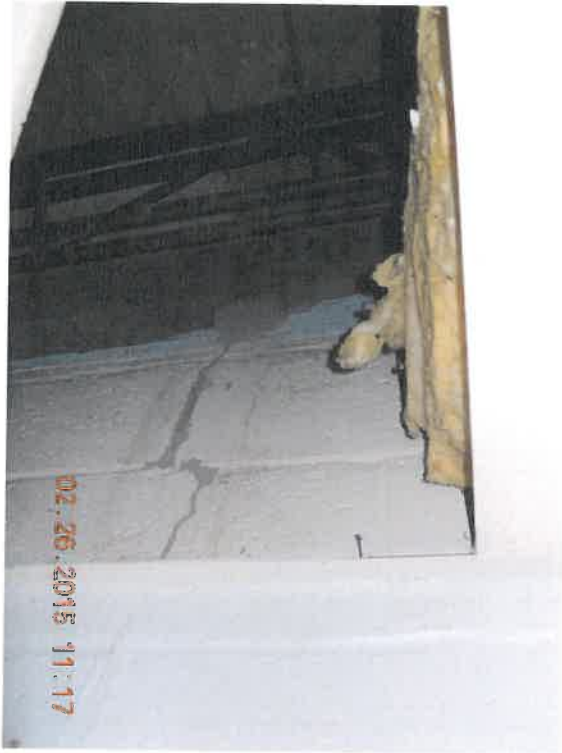
**Old crack repair**

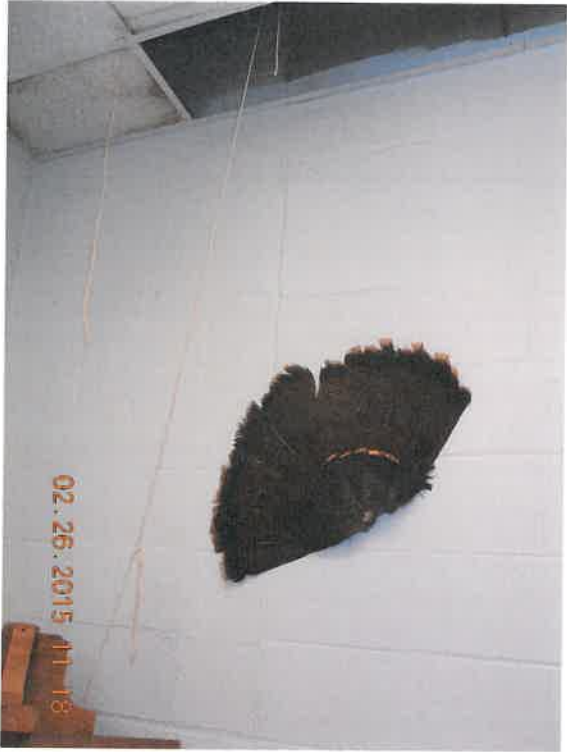
**Vertical crack at renovated wall**

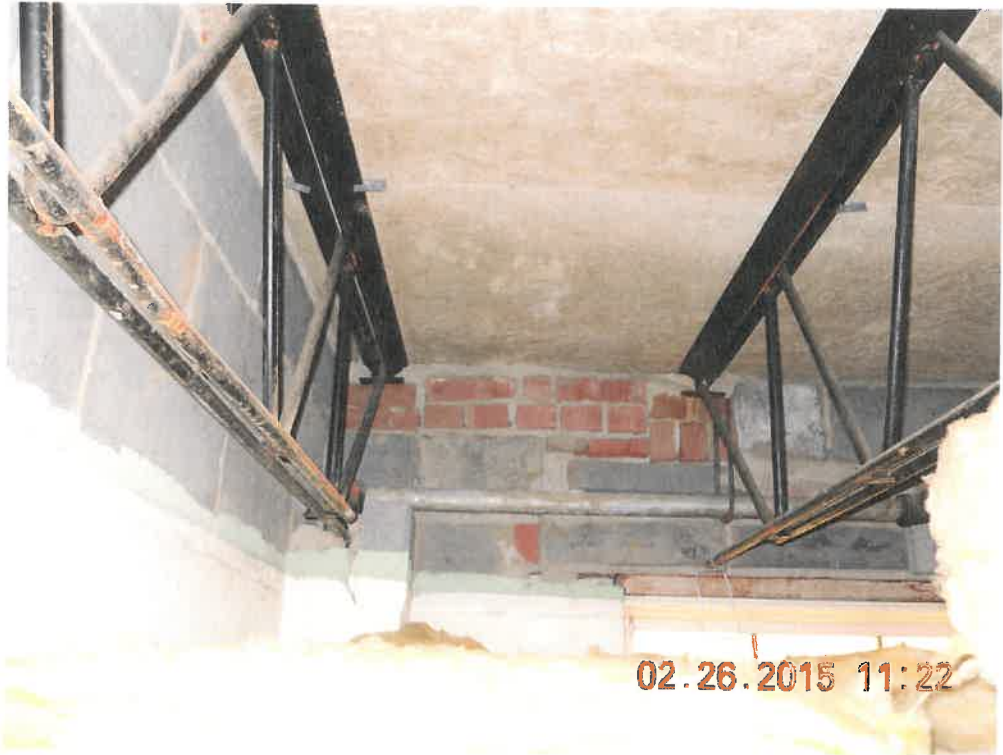
**Room 204 - renovated area**

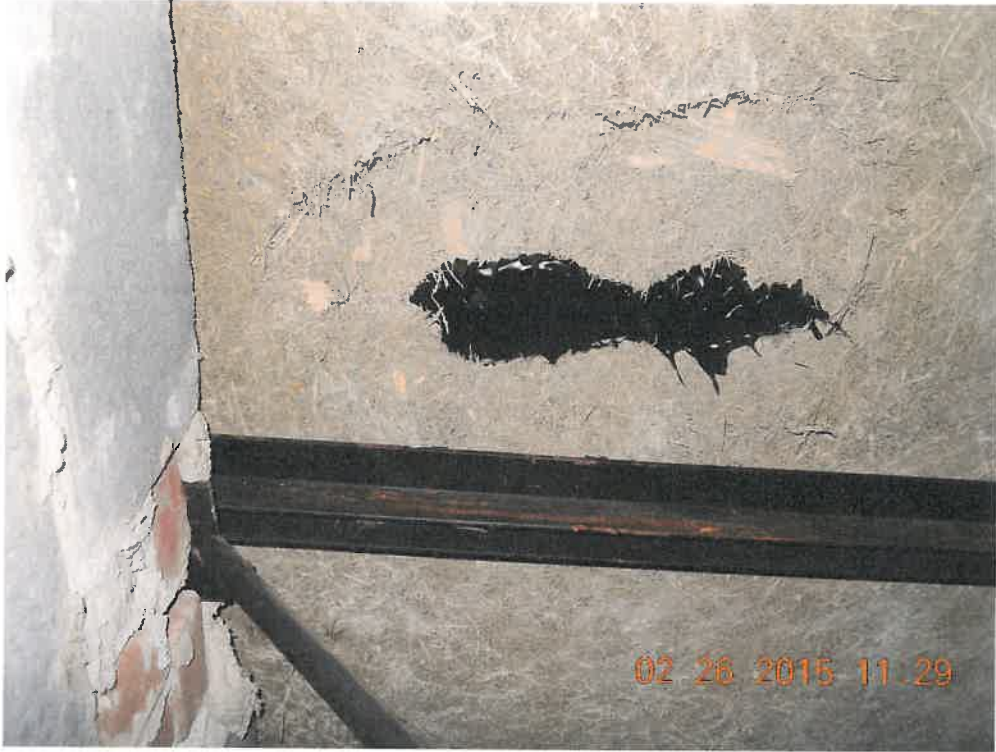
Girl's Bathroom	Damaged Tectum panel found. Pre-existing roofing damaged probably due to water leaks. Not related to snow event.
302 - 303	Spray foam insulation installed on underside of roof deck. Roof framing not observable.
Library workroom	Crack observed above door way. Wall extends to underside of roof deck, thereby not allowing for movement. No structural damage observed.
Library area	Observed wood deck planks supported by steel beams. No structural damage observed.
224	Metal lath and plaster above grid ceiling. Roof was not observable.
Girl's Locker Room	This is a low roof adjacent to a high roof. No structural damaged observed.
Gym	Roof purlins in good condition. No evidence of distress. No structural damage observed.

**Girl's bathroom - damaged Tectum roof deck**

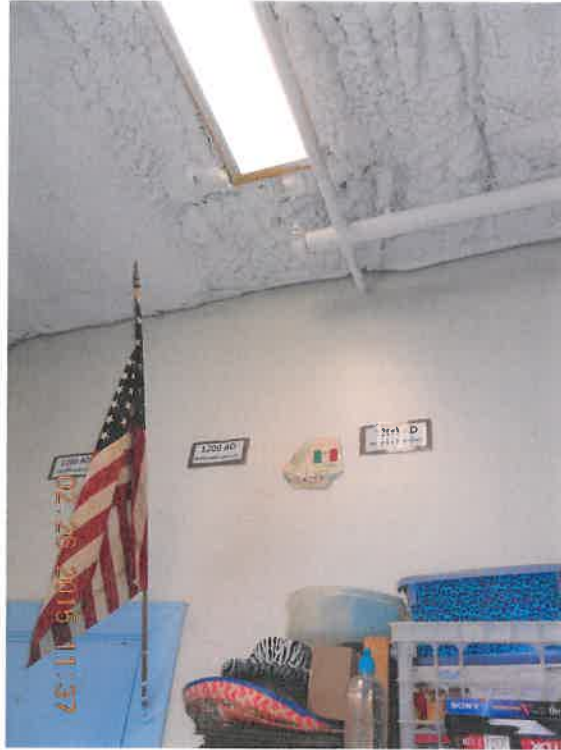
**Room 302 - 303 - foam insulation on roof deck.  
Not able to inspect.**

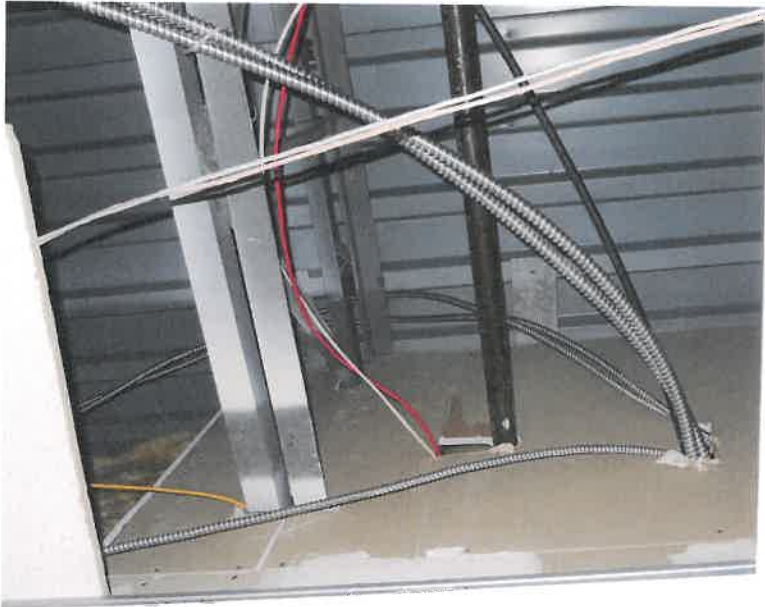
**Above library work room**

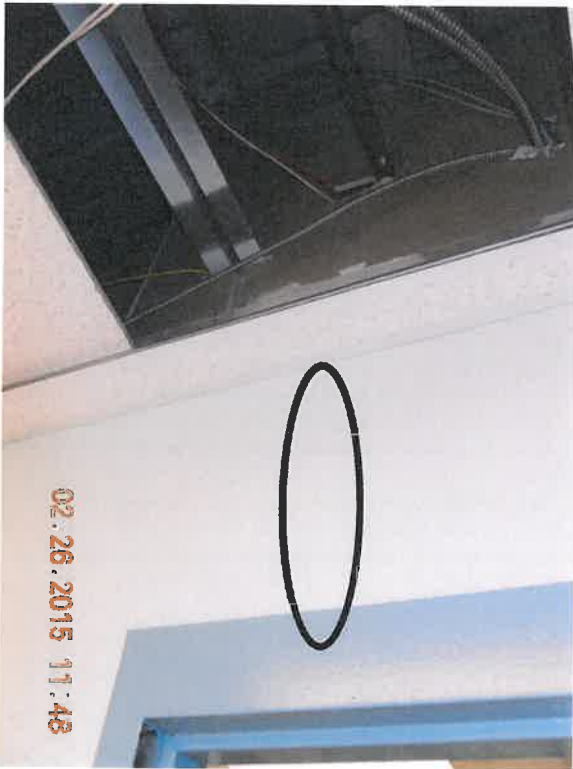
**Crack above door**

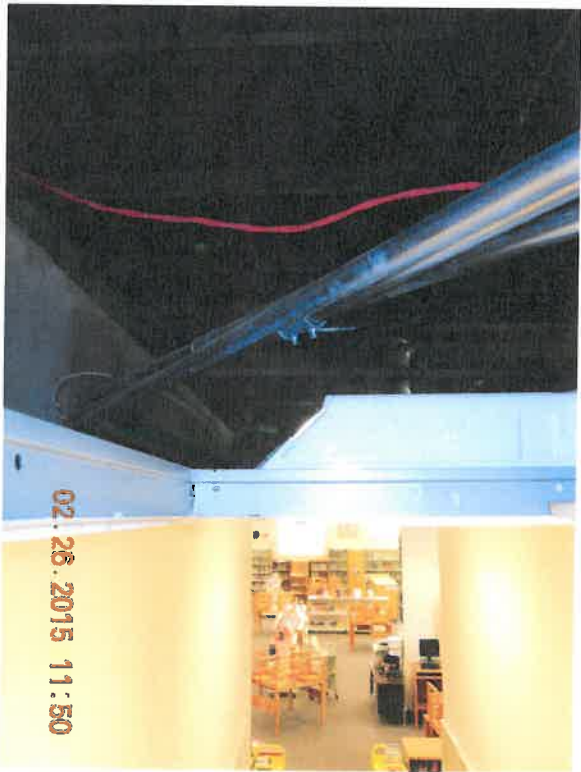
**Above old gym - now library**

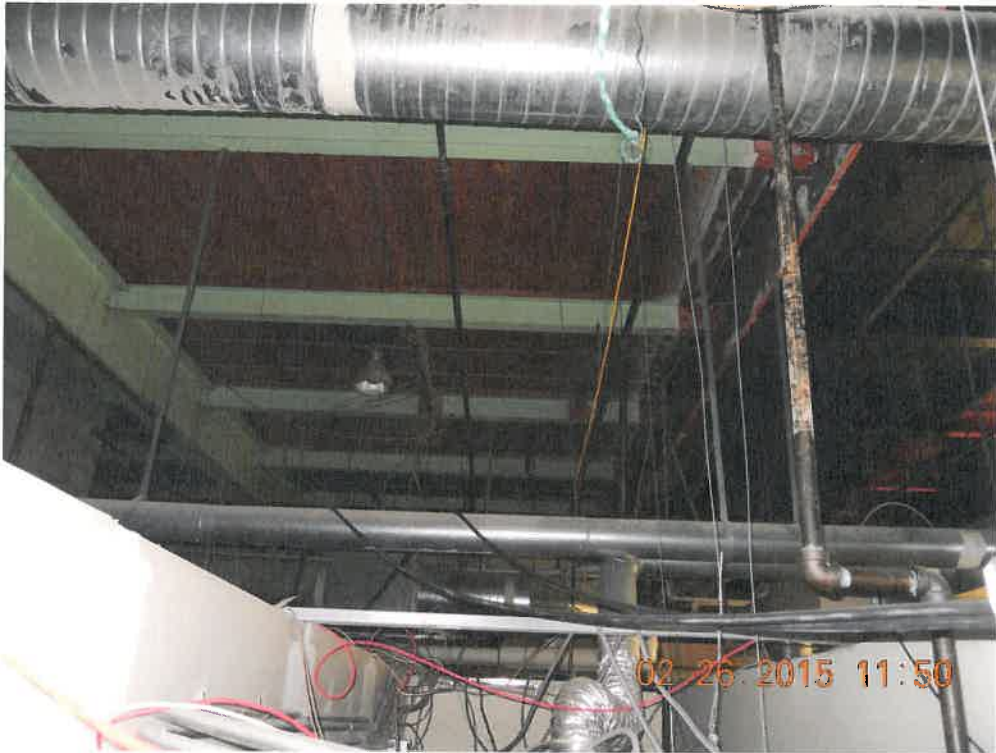
**Above library - wood deck and steel beams**

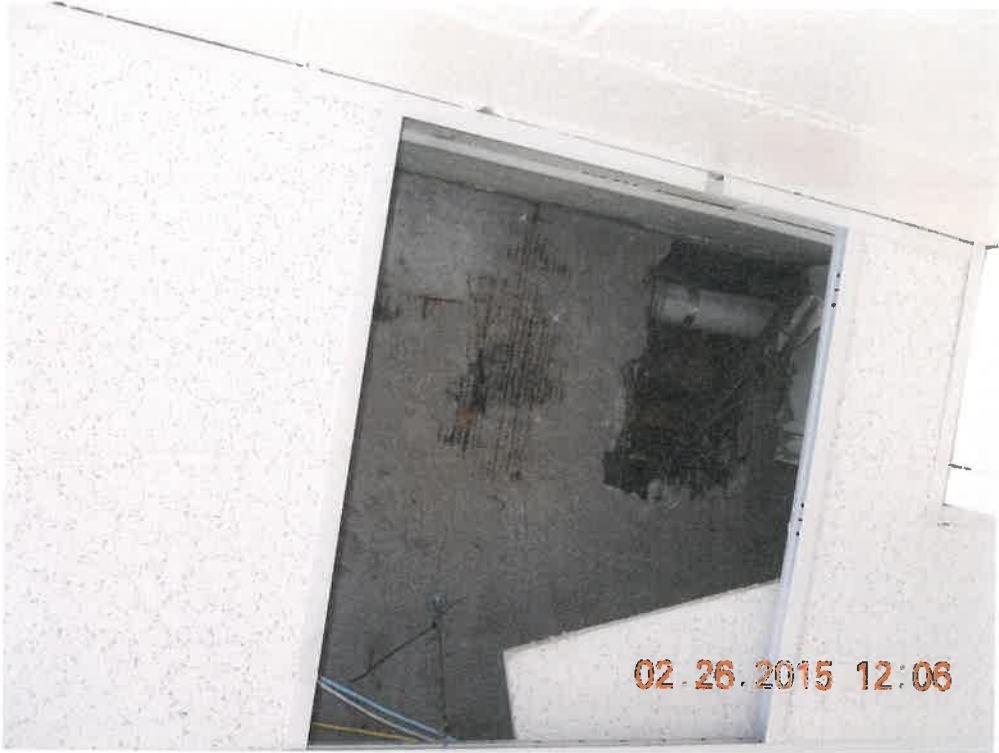
**Room 224 - old ceiling metal lath and plaster. Roof not observable.**

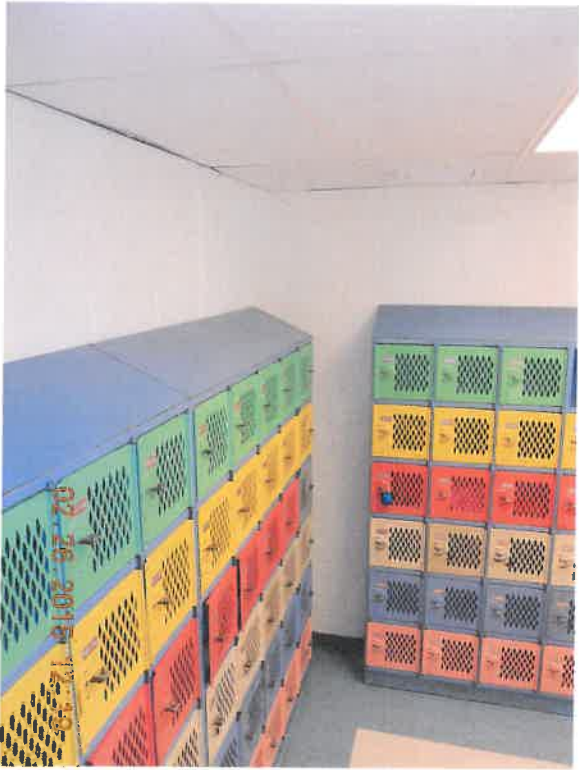
**Girl's locker room next to gym**

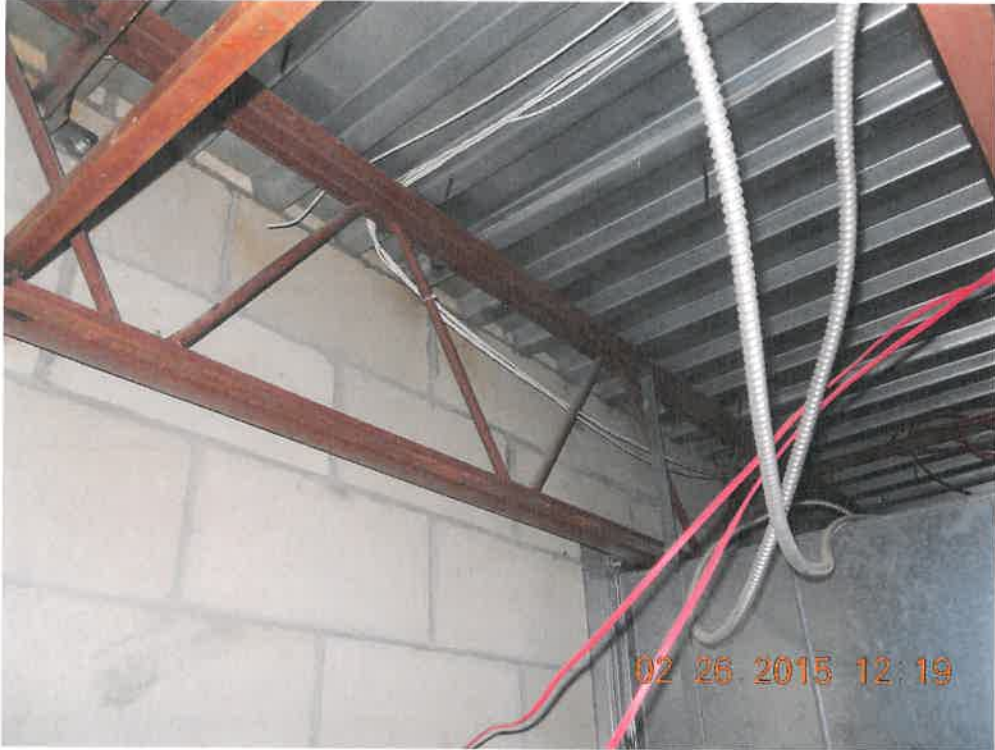
**No damage observed**

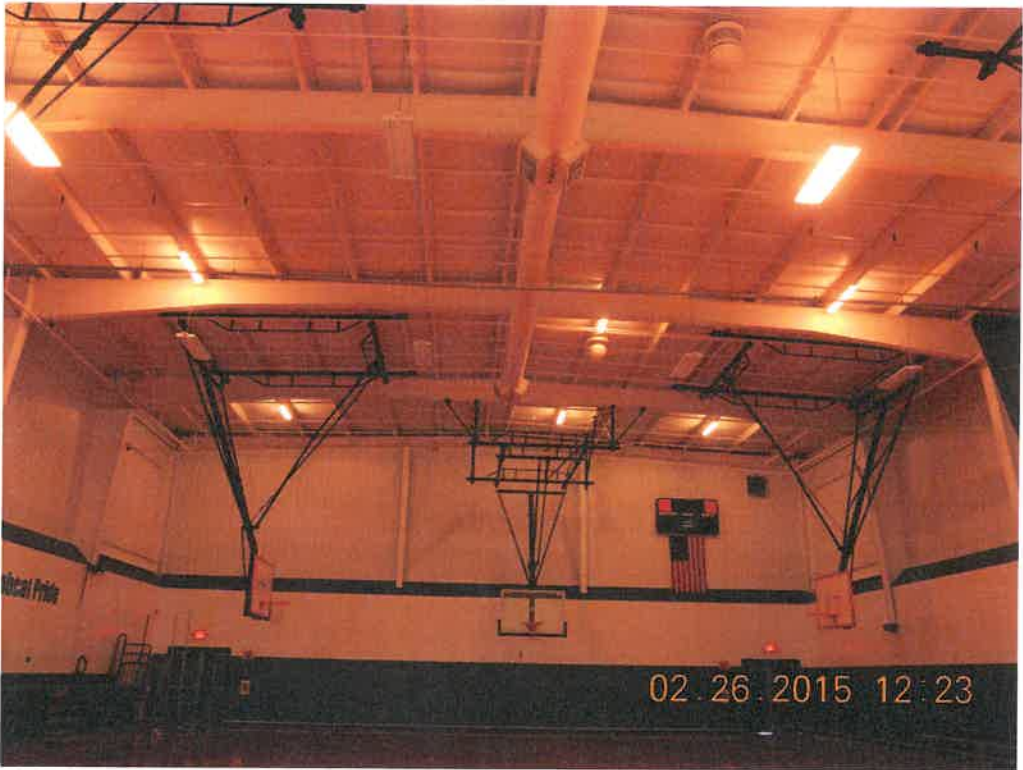
**Gym - no damage found**
