# OYSTER RIVER COOPERATIVE SCHOOL DISTRICT

## *Facilities & Program Analysis*

DAVIS GOUDREAU  
ARCHITECTS

# **FACILITY & PROGRAM ANALYSIS**

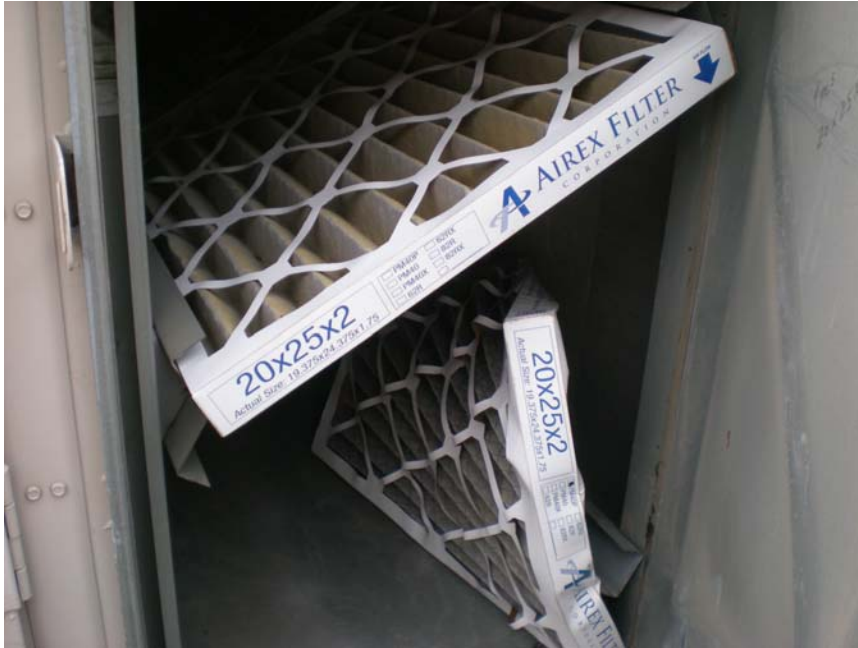
Due to the vast number of air handling systems and relative complexity of systems, it does not appear that adequate resources have been allocated to maintain equipment per the manufacturer's requirements. It appears that keeping up with filter changes is a challenge and is not likely that other important preventative maintenance measures (lubrication, belt changes, calibration, etc.) can be adequately addressed.

Crushed, dirty filters at Industrial Arts Air Handler (AHU-9)

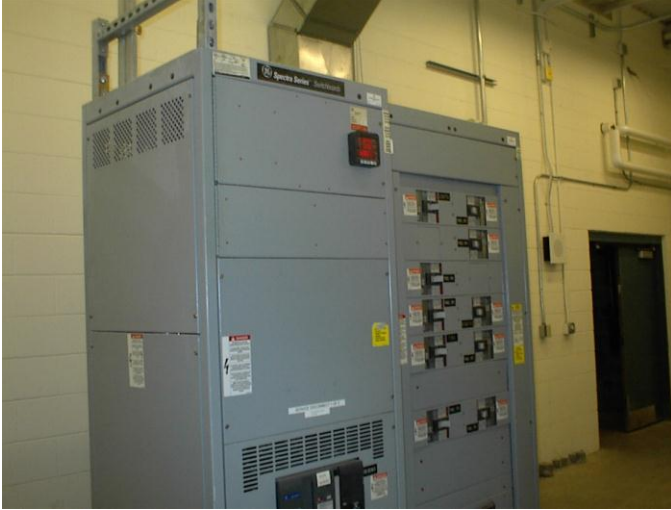
Photo #1

The main electric room is presently utilized as the standby and emergency distribution equipment room as well. There is adequate clearances in the main electric room and the egress door opens outward. Panic hardware exists on the egress door as required by N.E.C. Article 110.26(C)(2).

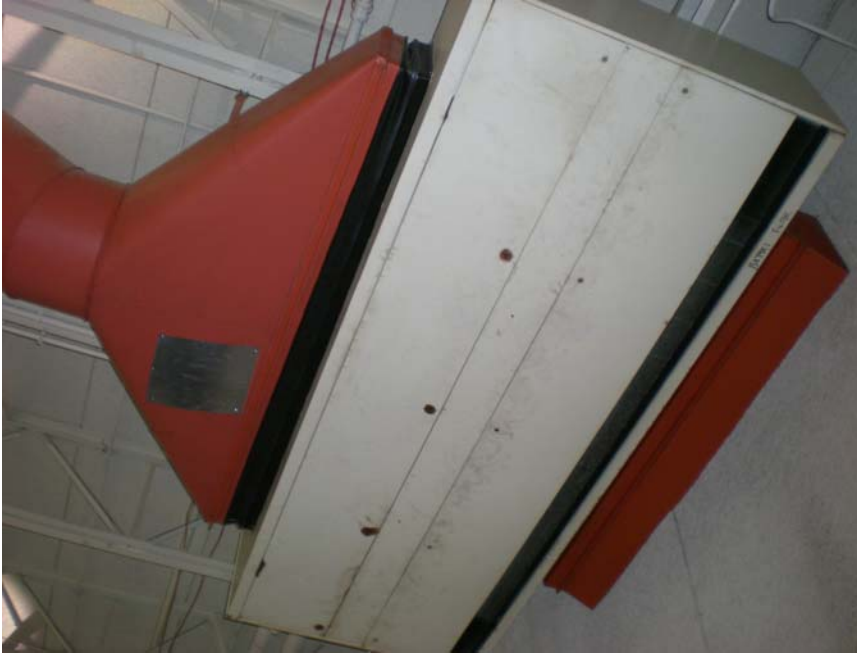
The Multi-Purpose Room and Music Rooms (#131, 132 & 134) are served by unit ventilators original to 1979 construction, each with intake air connections to exterior louvers (Room #132 intake is through a rooftop connection). These unit ventilator configurations use modulating intake and return damper arrangements that are generally difficult to control and ineffective for reliable ventilation.

Multi-Purpose Room Unit Ventilator (1979 Installation)

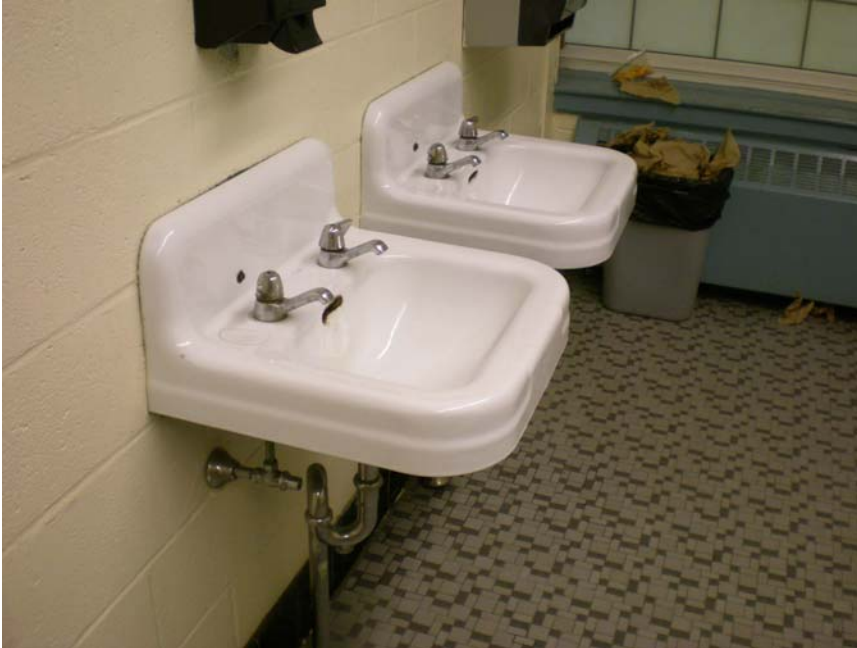
Plumbing fixtures throughout the facility remain from various periods – select toilet room fixtures were replaced during the 1995 renovations along with hot and cold water piping. Fixtures at the 3<sup>rd</sup> floor toilet rooms have recently had automatic flush valves installed. Multiple lavatories observed with separate hot and cold faucets, which don’t meet current plumbing code requirements for maximum allowable flow (0.5 GPM per IPC 2009 Table 604.4). Lavatories with single faucets also do not appear to meet current plumbing code requirement for maximum allowable flow.

Typical Bathroom Lavatories (age and condition vary throughout the school)

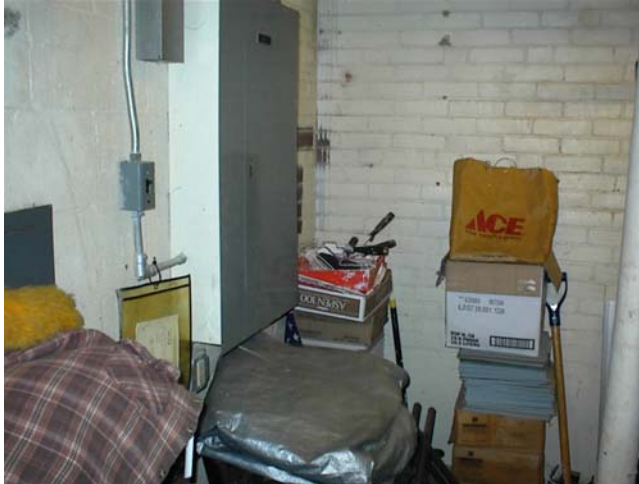
The main electric room B04 is presently utilized as a storage room (see photo #1) below. In violation of N.E.C. Article 110.26(B), all non electrical equipment should be removed from the electrical rooms. The main electric room door swings inward to the room and also is not equipped with panic hardware as required by N.E.C. Article 110.26(C)(2).

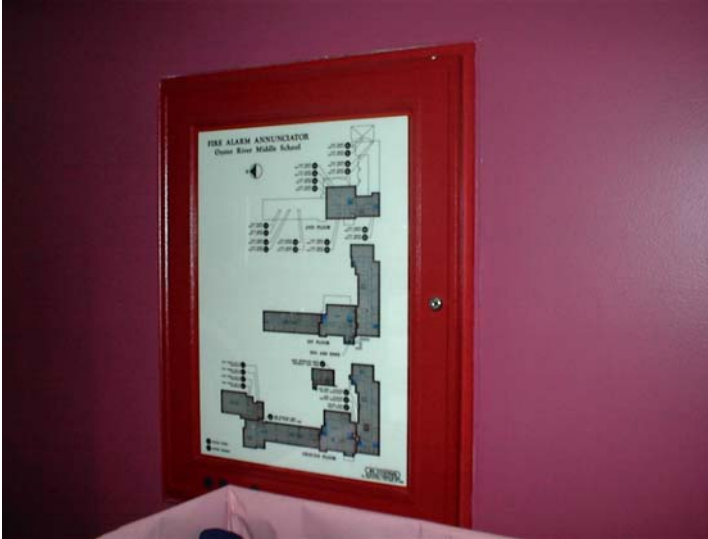
Photo #2

The main building is presently equipped with a conventional zoned, low voltage fire detection and signalling system as manufactured by Fire Control Instruments (FCI). The existing Fire Alarm System consists of a main control panel located in the main Entry Lobby at the first floor and remote system indicating and initiating devices including manual pull stations located at egress points throughout the building. Audio visual horn/strobe units are also strategically located throughout the complex and smoke or heat detectors are located in corridors, classrooms and open areas of the building. The main fire alarm control panel is tied into the Town of Durham Fire Department via the digital communicator. The audio/visual device coverage does not appear to comply with current NFPA 72 spacing requirements and the mounting heights are not ADA or NFPA compliant. The digital communicator is tied into the fire alarm system and will notify the monitoring company of any "alarm" and/or "trouble" signals in the system. There is a graphic annunciator located in the main entry lobby of the building (See photo #2).

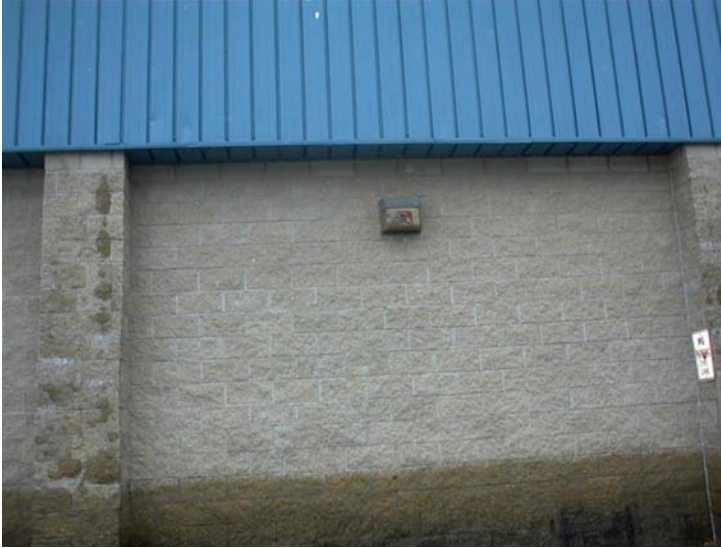
Photo #3

H.I.D. type, lensed, wall mounted wallpack luminaires illuminate the main parking lot and access drive around the building. As we performed our inspection during the daylight hours, we cannot comment on the adequacy of the exterior lighting levels. The wallpack fixtures appear to be in fair condition, although some of the lenses are yellowed or broken. (See photo #3).

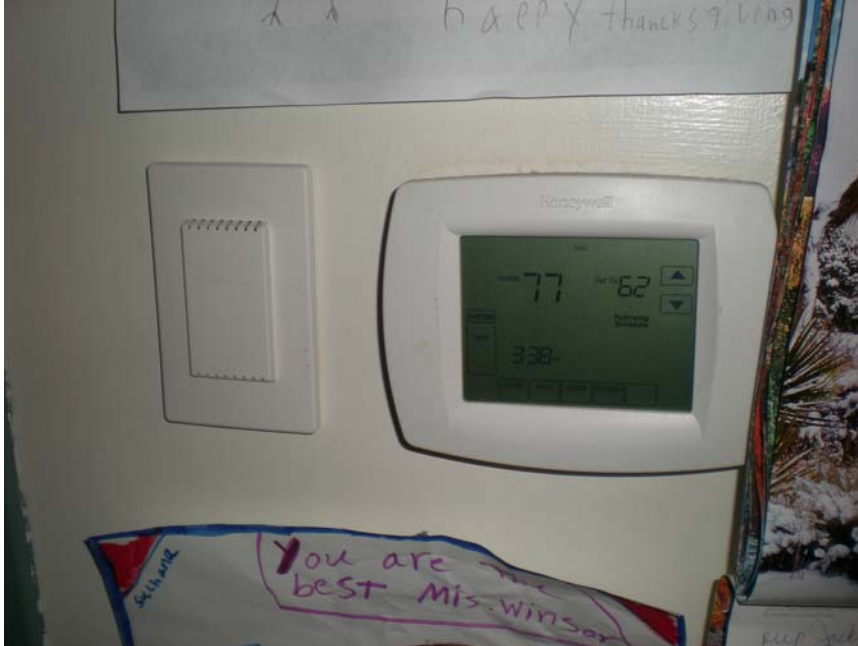
It was observed in several classroom locations that room temperature readings were significantly higher than set point (during relatively cold weather – approx. 39°F outdoor conditions). This indicates potential issues with programmable thermostats and finned tube control valves or that ventilation air is being delivered too warm by the central systems, overheating these spaces.

Programmable T-stat and CO2 sensor (typical for classrooms)

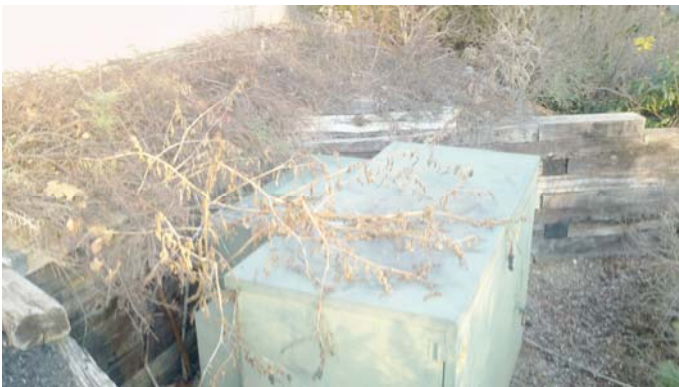
Photo #1

Building electrical power emanates from a PSNH pad mounted distribution transformer located behind some shrubs in the entry courtyard. The pad mounted transformer appears to be rated for 300 KVA with an input voltage of 13,800 volts delta and an output voltage of 120/208 volts wye. The primary service entrance conductors for the transformer run underground from pole # PSNH 318A-4 to the PSNH pad mounted transformer. The secondary service entrance conductors for the building run underground from the pad mounted distribution transformer to the main switchboard located in the first floor main electric room #165. PSNH presently owns and maintains the primary electric service feeder, and the pad mounted transformer, as the building is secondary metered by PSNH. The pad mounted transformer is getting covered by shrubs and bushes. These should be cut back to maintain clearance around the transformer. See photo #1.

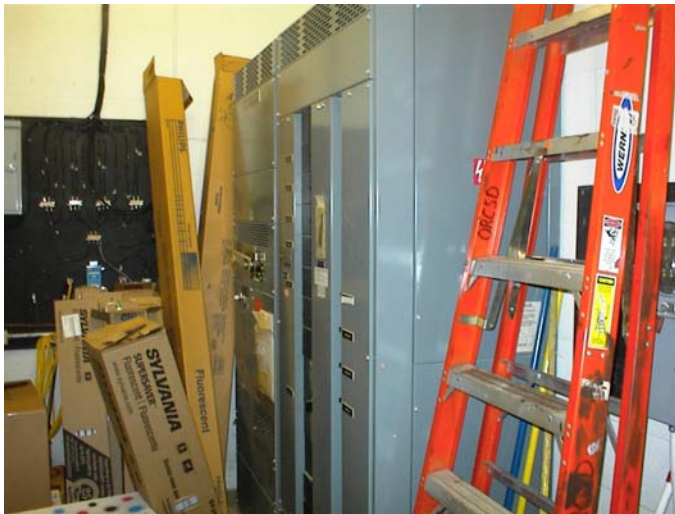
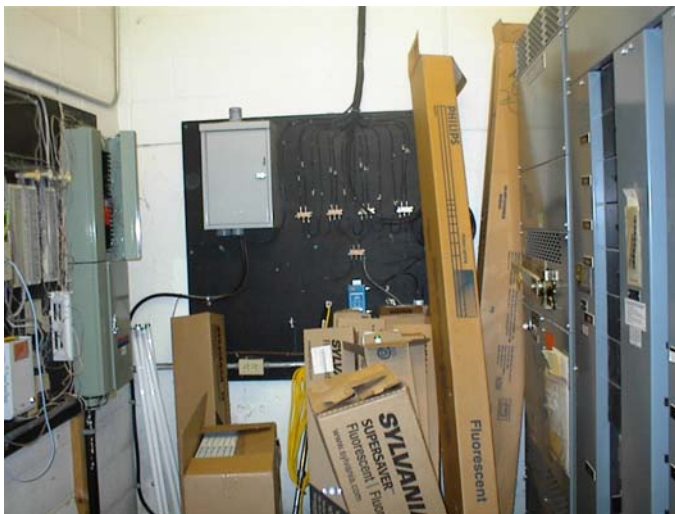
The main electric room is presently utilized as a storage room (see photos #2 and #3) below. In violation of N.E.C. Article 110.26(B), all non electrical equipment should be removed from the electrical rooms. The main electric room door swings inward to the room and also is not equipped with panic hardware as required by N.E.C. Article 110.26(C)(2).

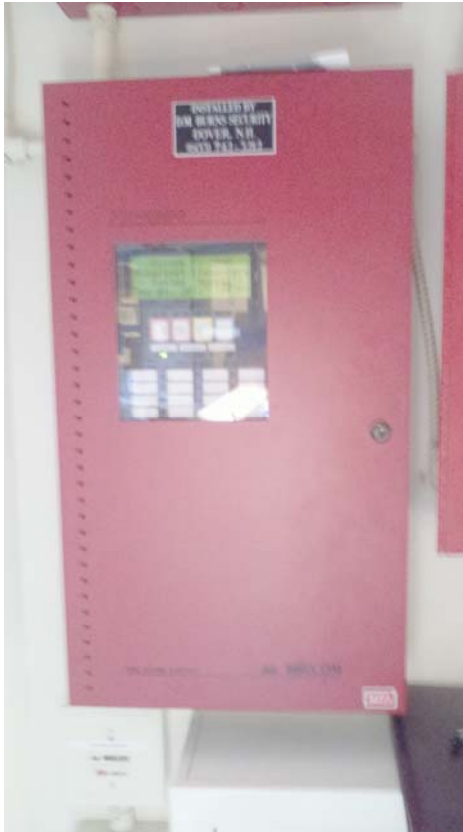
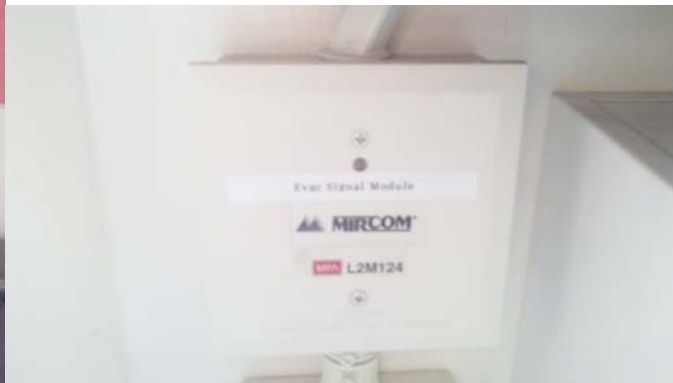
Photos #4 & 5

The temporary classroom building is also equipped with a fire detection and signaling system. At the time of our field inspection, we could not locate the fire alarm control panel in this building.

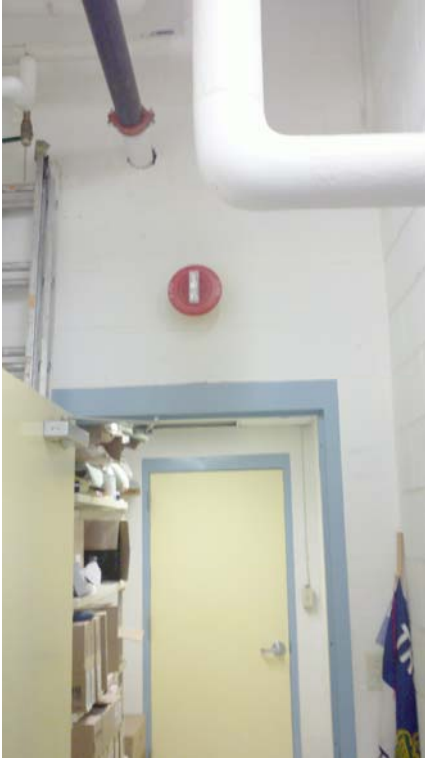
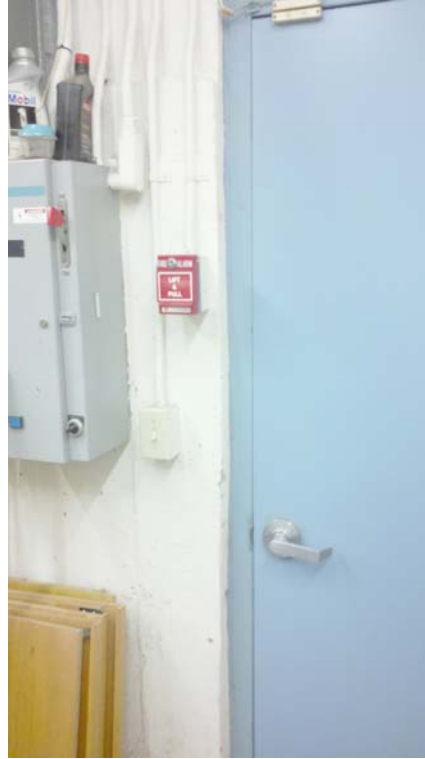
Photos #6 & 7

It appears that most of the buildings electrical controls and fire alarm devices are in compliance with the height and access requirements of the Americans with Disabilities Act and the State of New Hampshire Architectural Access Barrier Board requirements. We did observe some lighting control switches that were mounted above the allowed height for switch controls. We also observed that a few manual stations and audio/visual devices are not mounted at ADA compliant heights. See photos #6 and #7

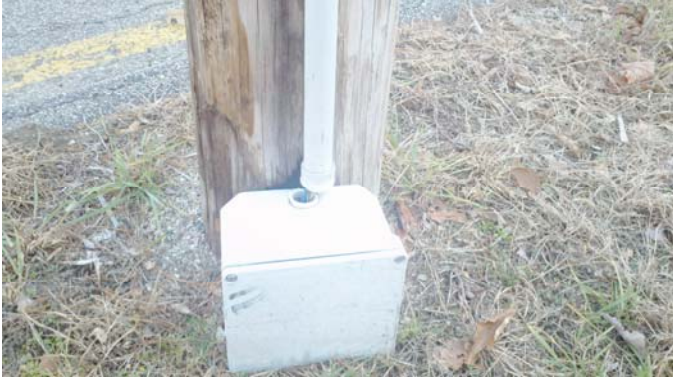
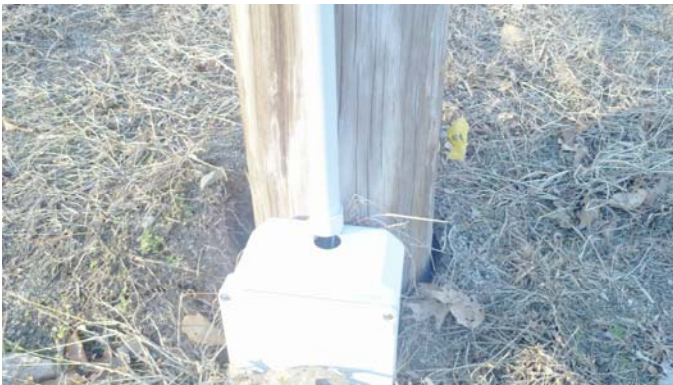
H.I.D. type, lensed, pole mounted floodlight luminaires illuminate the main parking lot and access drive around the building. These fixtures are owned and maintained by PSNH. As we performed our inspection during the daylight hours, we cannot comment on the adequacy of the exterior lighting levels however, there does not appear to be enough luminaires to provide adequate security lighting. The floodlight fixtures appear to be in fair condition. There are two locations where the pole mounted riser conduit has broken away from the junction box, exposing the wiring to physical damage. See photos #8 and #9.

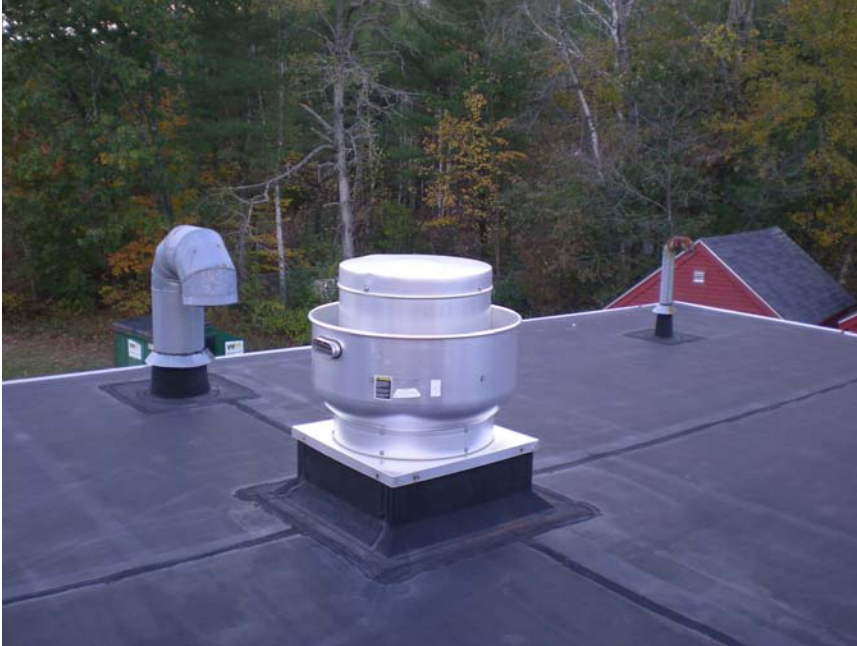
No direct make-up air system is provided for the kitchen. The grease hood exhaust fan and dishwasher hood exhaust fan total 4,300 CFM airflow (3,600 CFM & 700 CFM fans). During operation, significant negative pressurization is expected in the kitchen and adjacent areas.

An exhaust grille and ceiling fan was observed in the ceiling of the dishwashing area, connected to a discharge duct to the roof. There is no exhaust hood for the dishwasher.

Kitchen Hood Exhaust Fan and Dishwasher Exhaust Fan Discharge

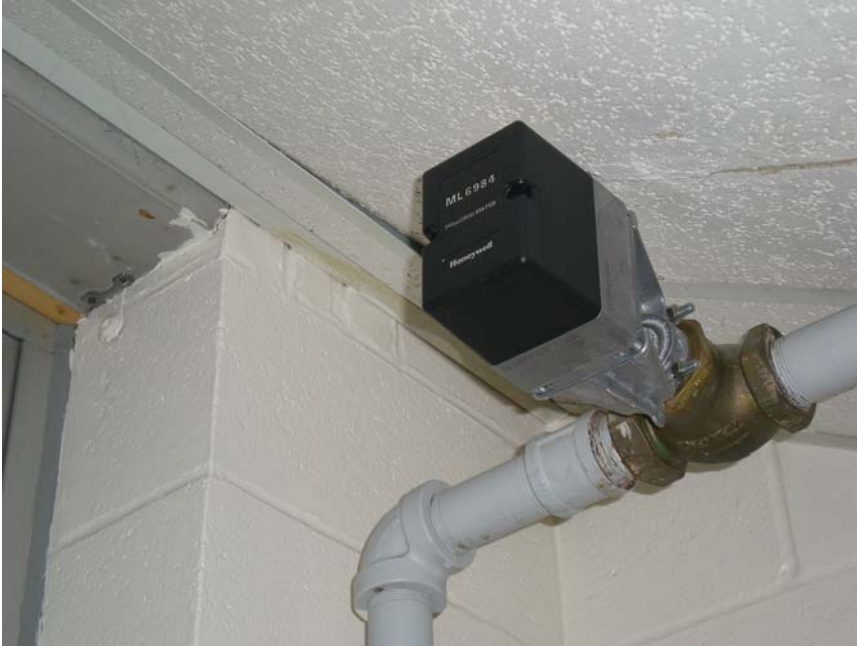
Older vintage control valves and actuators were observed to be in service at multiple locations.

Older vintage heating zone control valve & actuator

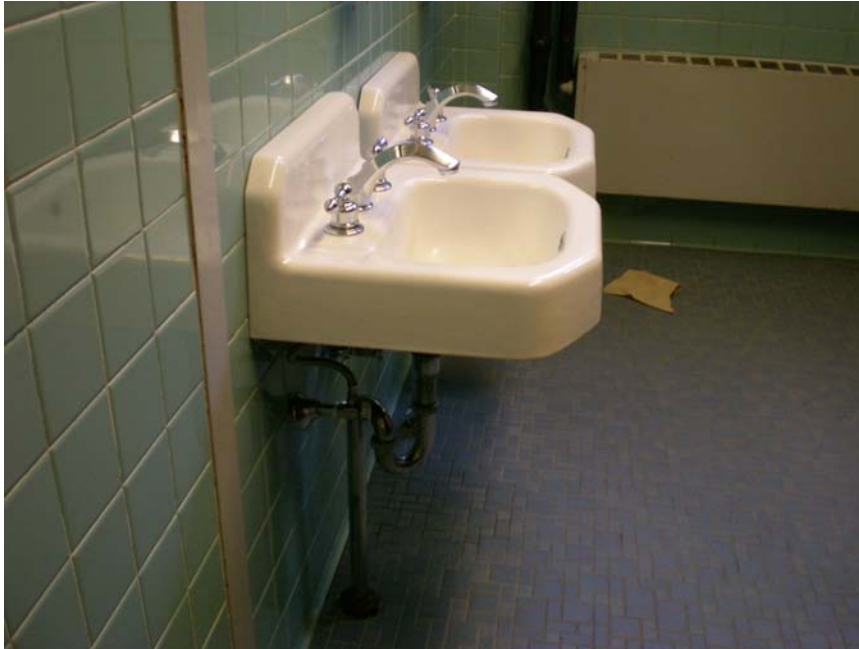
Plumbing fixtures throughout the facility remain from various periods. Fixtures in the north wing were provided during the 1994 expansion while older fixtures remain in service in older sections of the building. Automatic flush valves were observed at some locations. The lavatory in TOILET 36 is equipped with two faucets (hot and cold).

Lavatories at BOYS TOILET 52

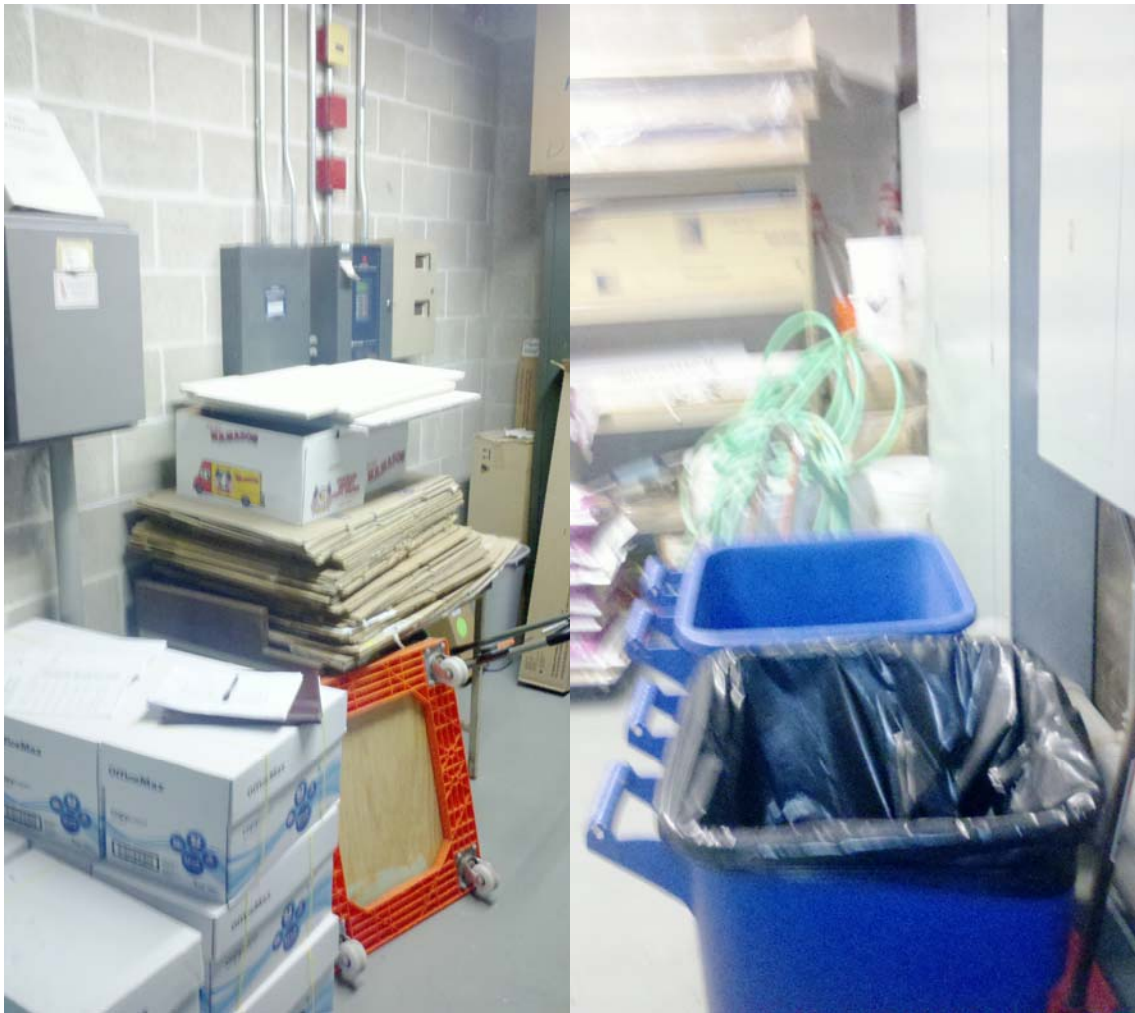
Photos #2 and #3

The main electric room is presently utilized as a storage room (see photos #2 and #3 below). In violation of N.E.C. Article 110.26(B), all non electrical equipment should be removed from the electrical rooms.

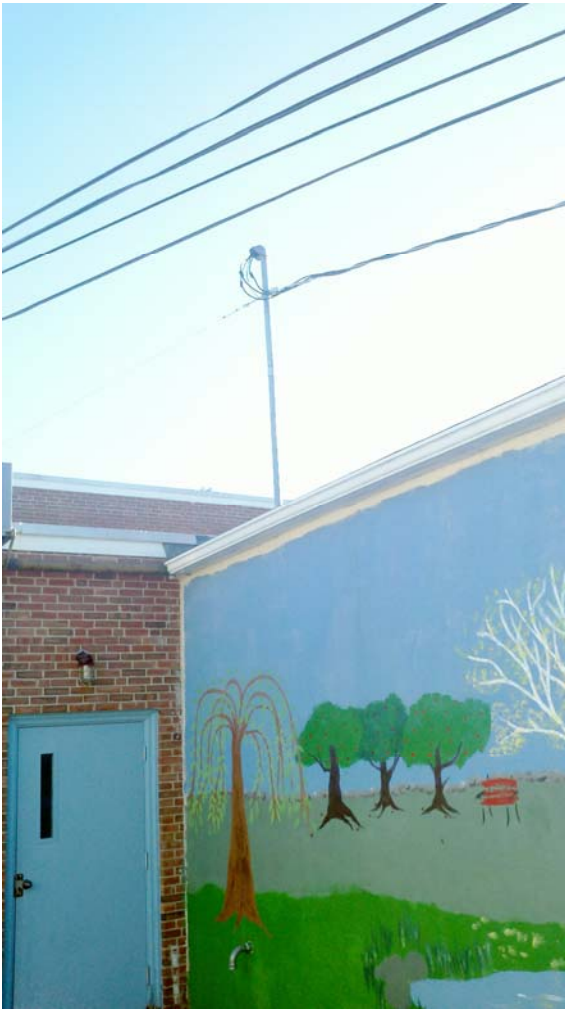
Photo #4

There is a second electrical service to the building which also originates from the outdoor NHEC pole mounted transformers. (See photo #4). This overhead secondary electrical service is dedicated for the electric fire pump which is located in the tank room.

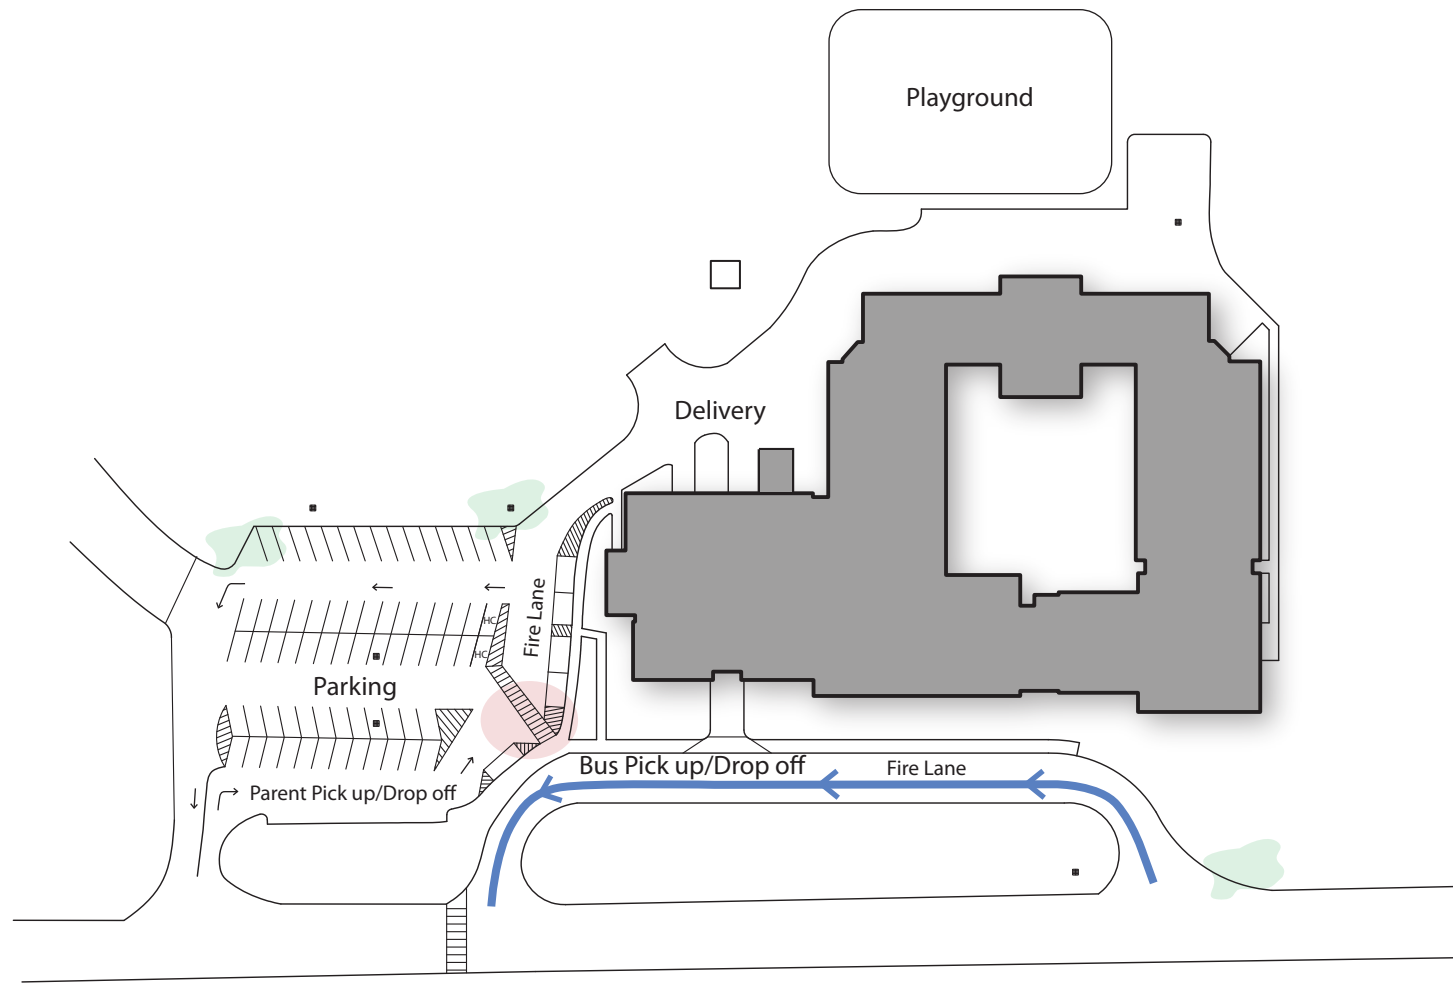
1 EXISTING SITE PLAN  
SCALE: 1:100

Drainage Issues/Ponding Area
