# Facility Audit Report

## New Hampshire Local Audit Exchange Program

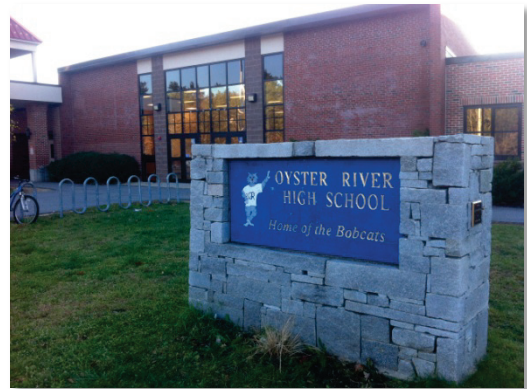
Figure 1 – Oyster River High School

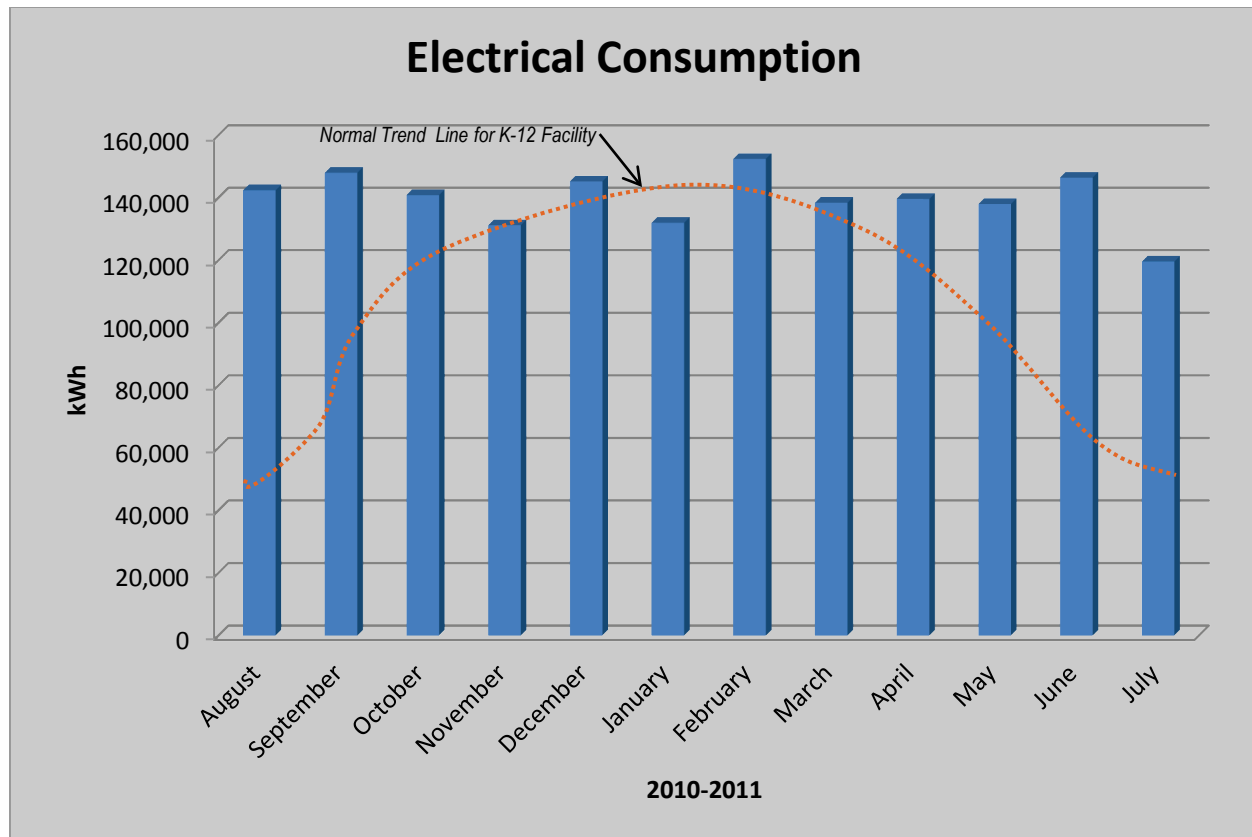
Figure 2 – Electric Consumption (2010-2011)

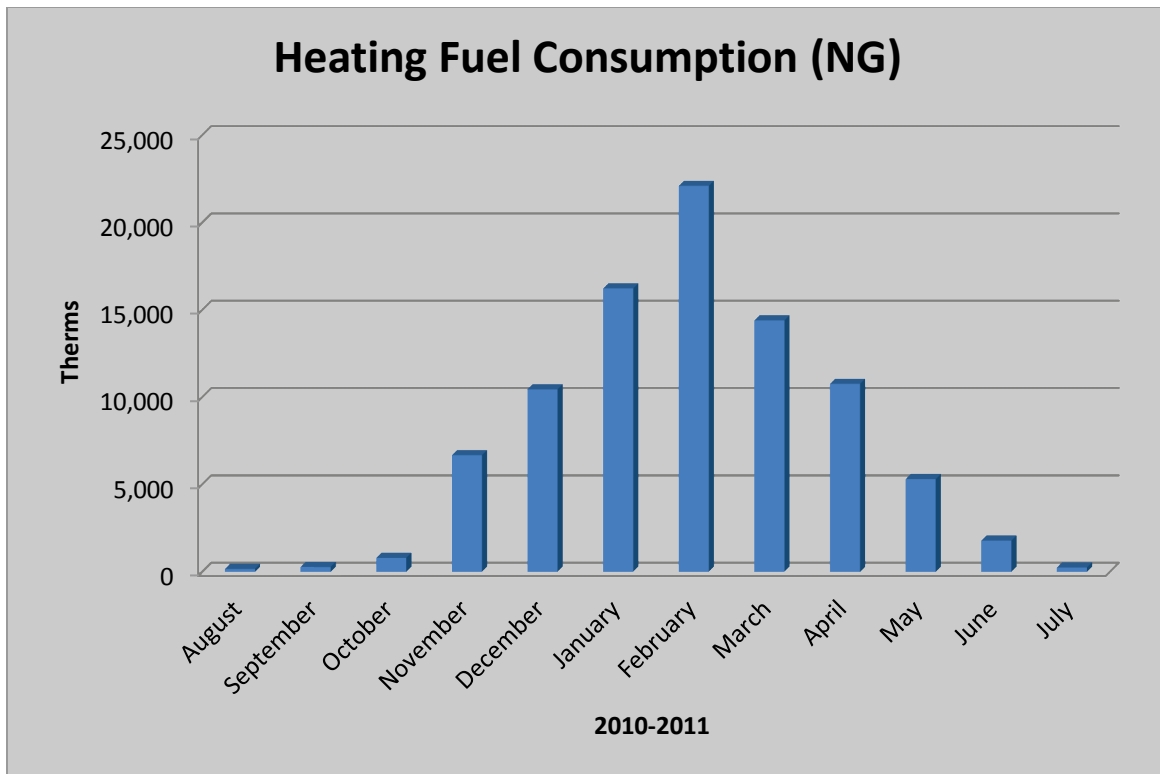
Figure 4 – Heating Fuel Consumption (2010-2011)

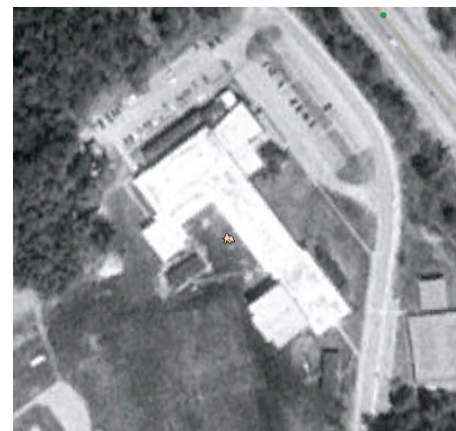
Figure 6 – Aerial Photograph of ORHS (1998)

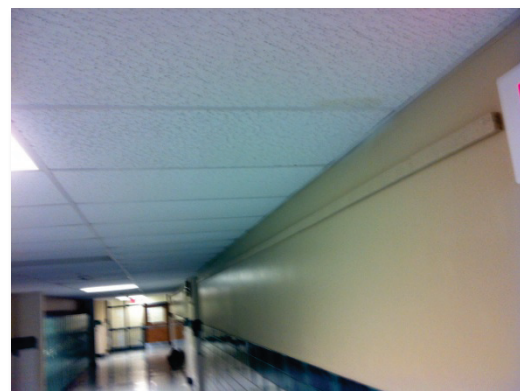
Figure 7 – Sagging Ceiling Tiles & Water Stains

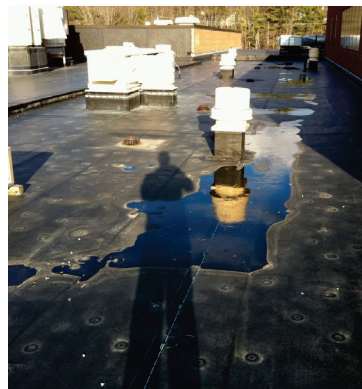
Figure 9 – Ponding Water

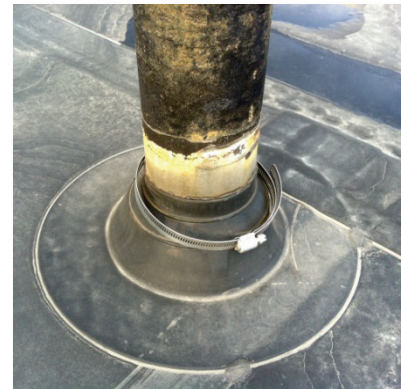
Figure 8 – Vent Penetration (note untightened band clamp)

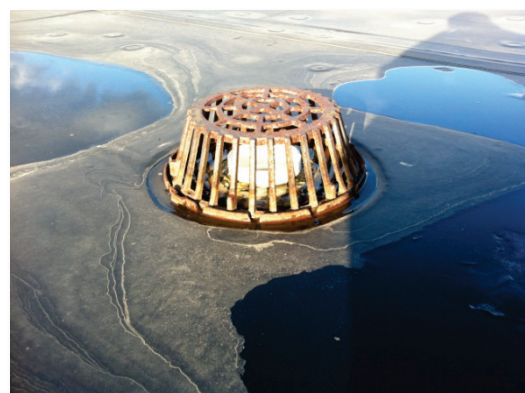
Figure 10 – Scupper Drain (note drain pipe invert is 2" above deck)

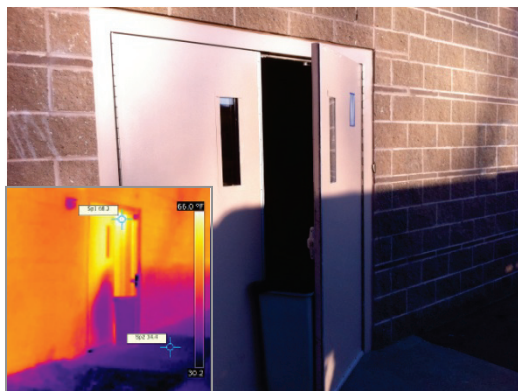
Figure 12 – Propped Open Rear Entry Door

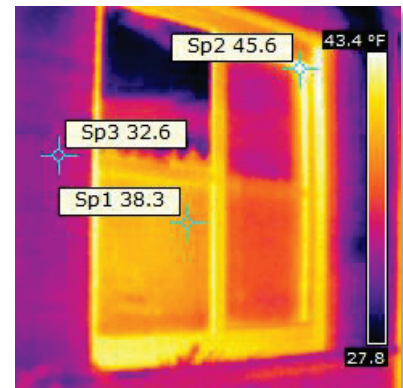
Figure 11 – Infra-Red Image of Window

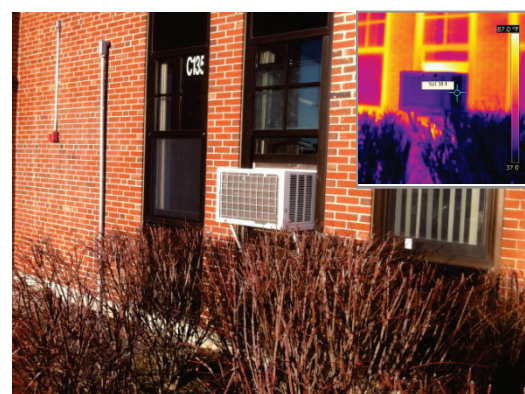
Figure 13 – Window A/C Unit (January)

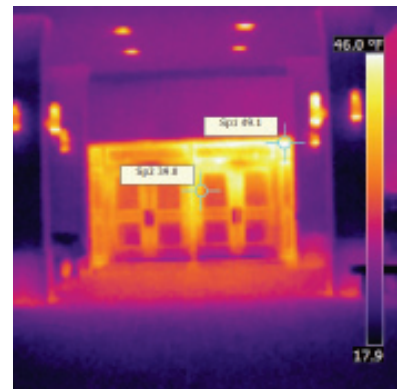
Figure 14 – Main Entry Doors

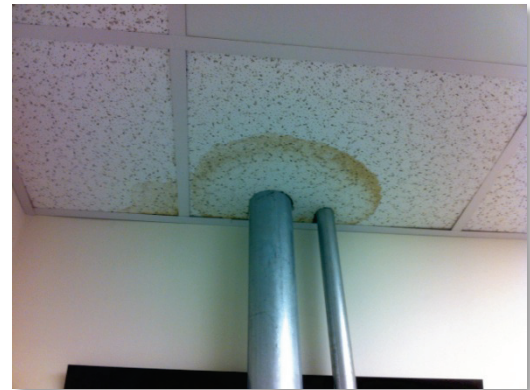
Figure 17 – Water Stains around Electrical Panel Conduit

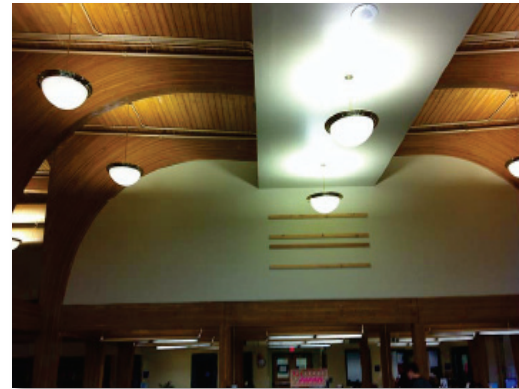
Figure 18 – Library Light Fixtures

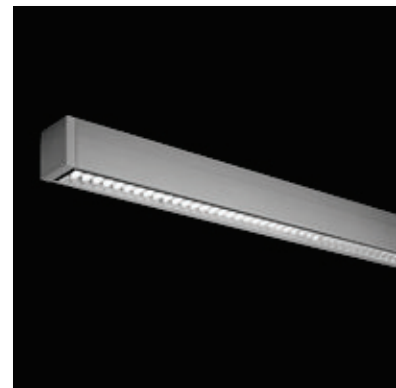
Figure 19 – Suspended T-8 Fixture

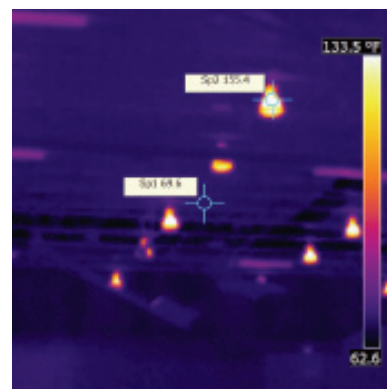
Figure 20 – Gymnasium Light Fixtures

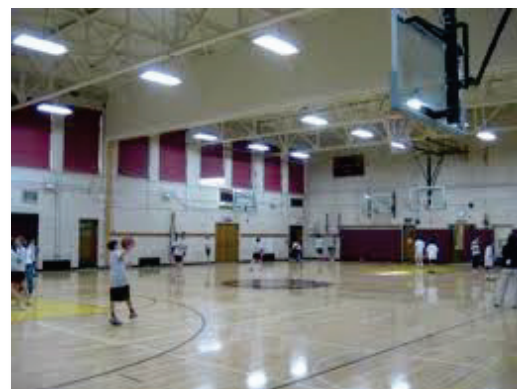
Figure 21 – Super T-5 Fixtures (typ.)

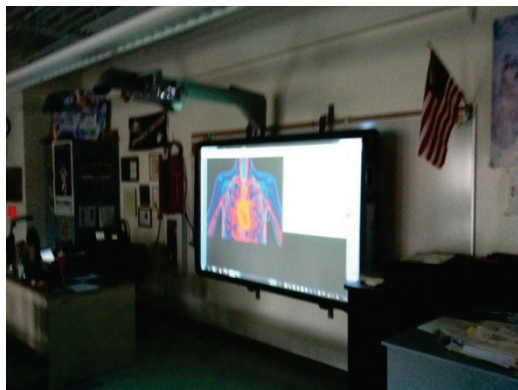
Figure 22 – Operating SmartBoard in Unoccupied Classroom

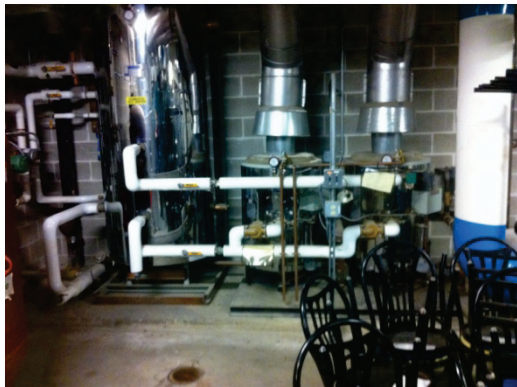
Figure 23 – Domestic Hot Water System

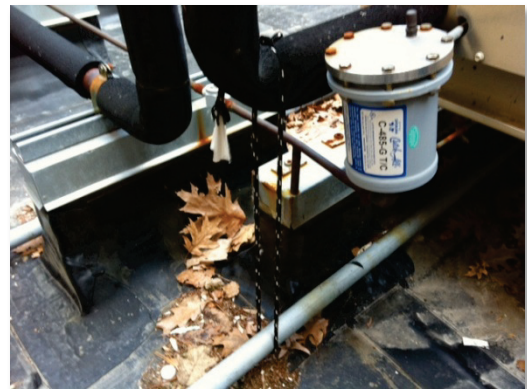
Figure 27 – Shoelace Tied to Condensate Pipe as Electrical Conduit Support

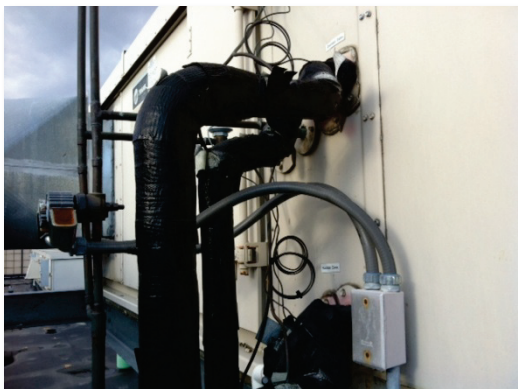
Figure 26 – Duct Tape on Deteriorated Pipe Insulation

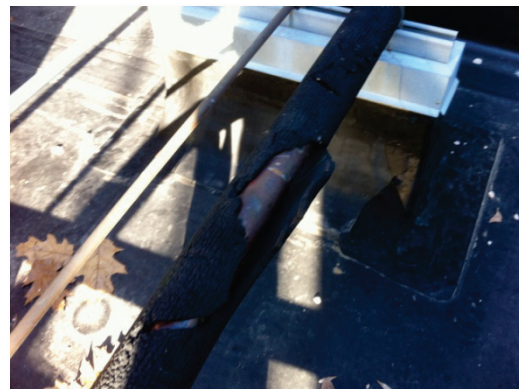
Figure 25 – Deteriorated Condenser Pipe Insulation

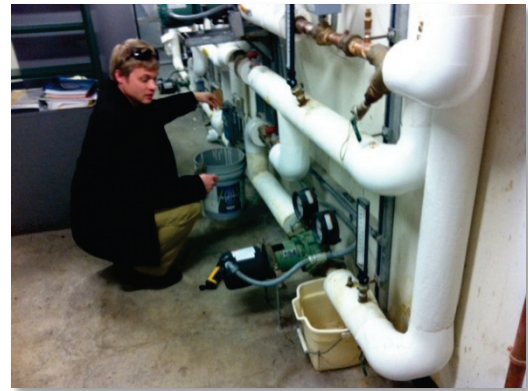
Figure 28 – Leaking Hydronic Pumps with Buckets

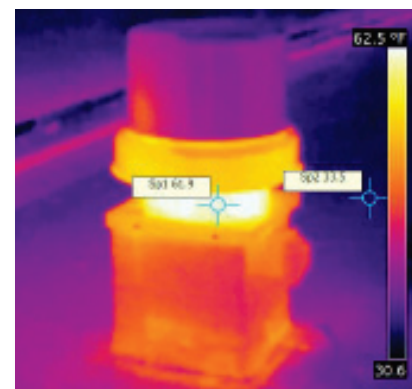
**Figure 29 – Operating Rooftop Exhaust Fan (typ.)**

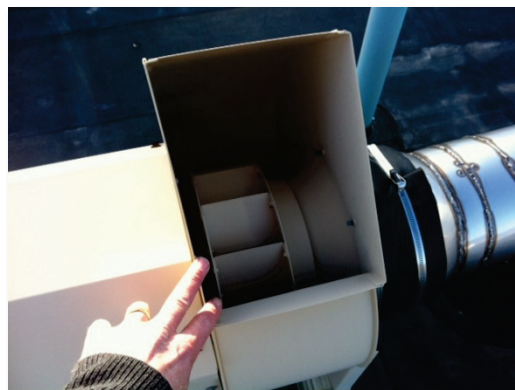
Figure 30 – Lab Exhaust Ventilator w/ no Guard

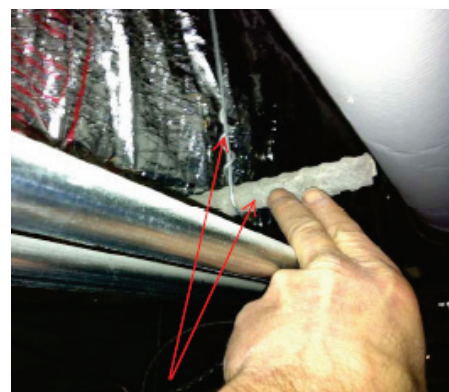
Figure 32 – Rebar & Wire Used for Duct Support

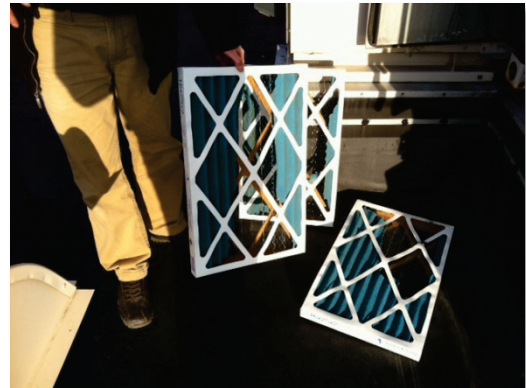
Figure 34 - Deteriorated AHU Air Filters

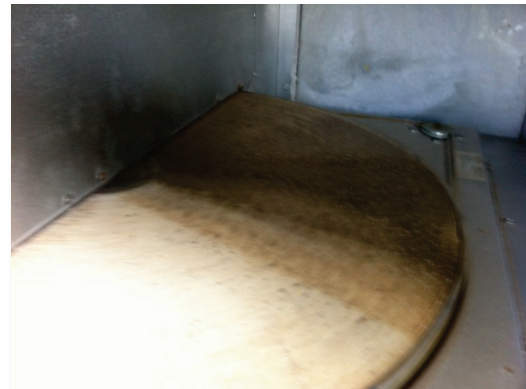
Figure 35 - AHU Energy Recovery Wheel

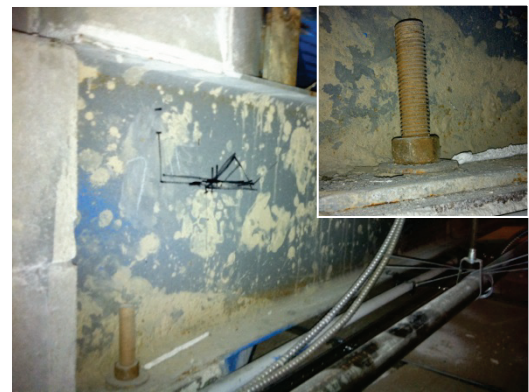
Figure 36 – Structural Beam with Loose Bolted Flange Connection and no Fireproofing

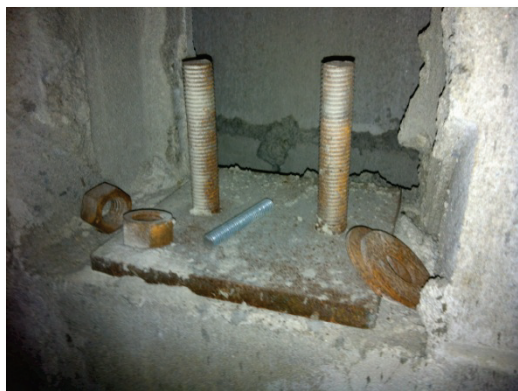
Figure 37 – CMU Wall Plate with Missing Bolted Connections

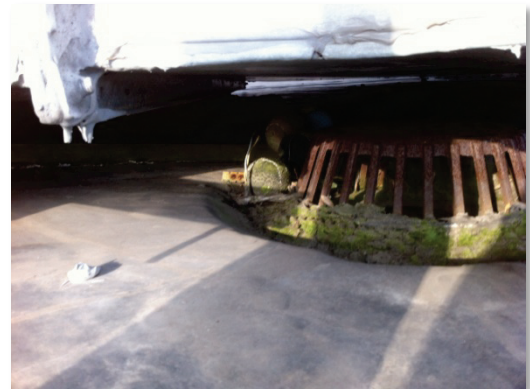
Figure 38 – Clogged Scupper under AHU-4

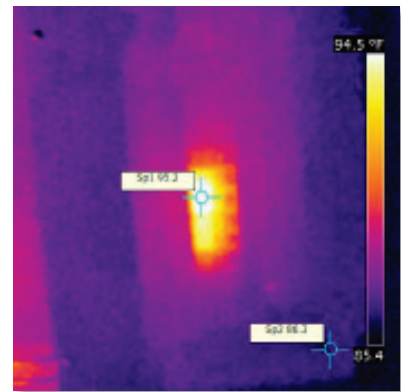
Figure 40 – Potentially Overloaded Electrical Circuit

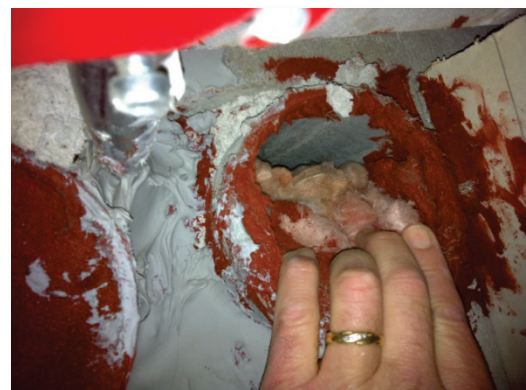
Figure 41 – Unsealed Conduit in Fire Barrier Wall

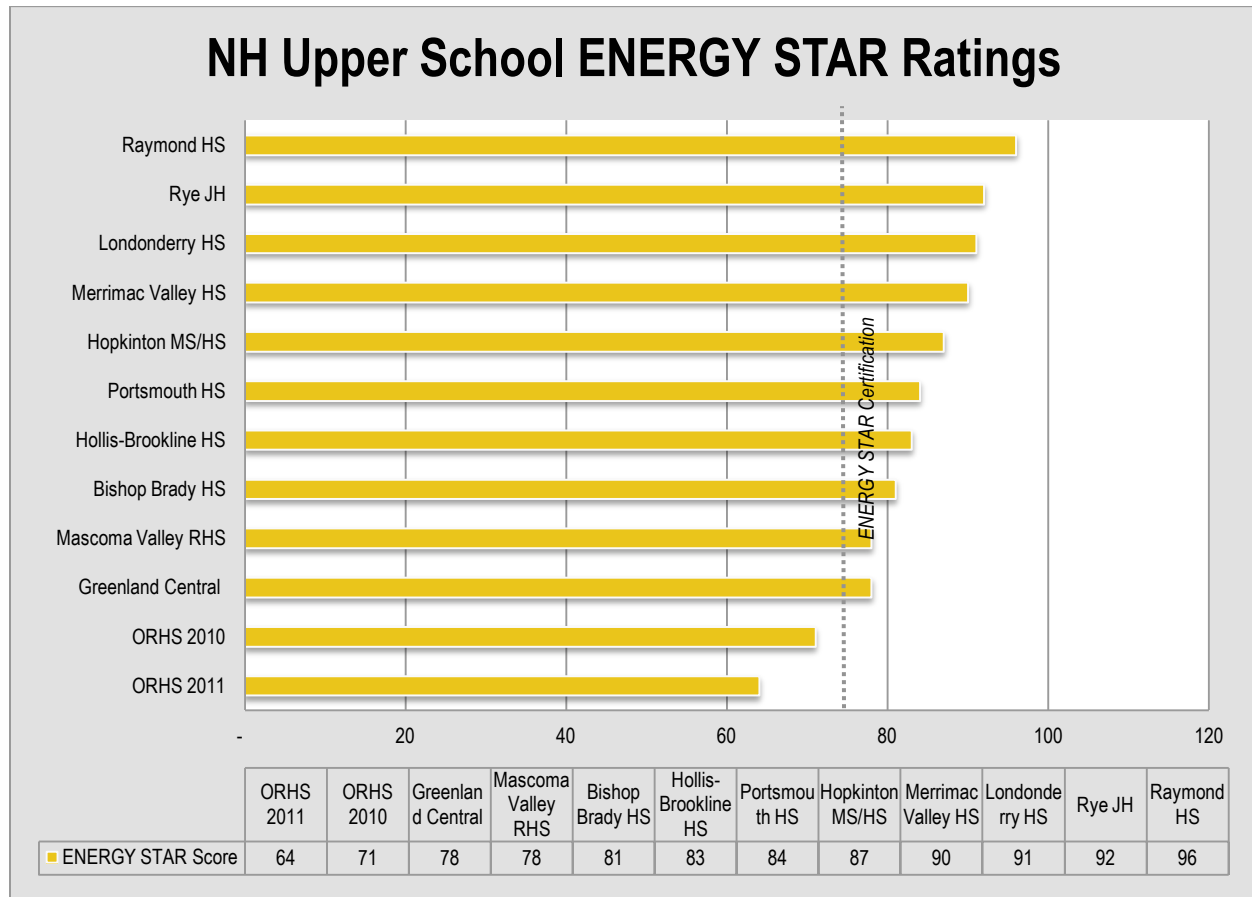
Figure 42 – Regional ENERGY STAR Ratings

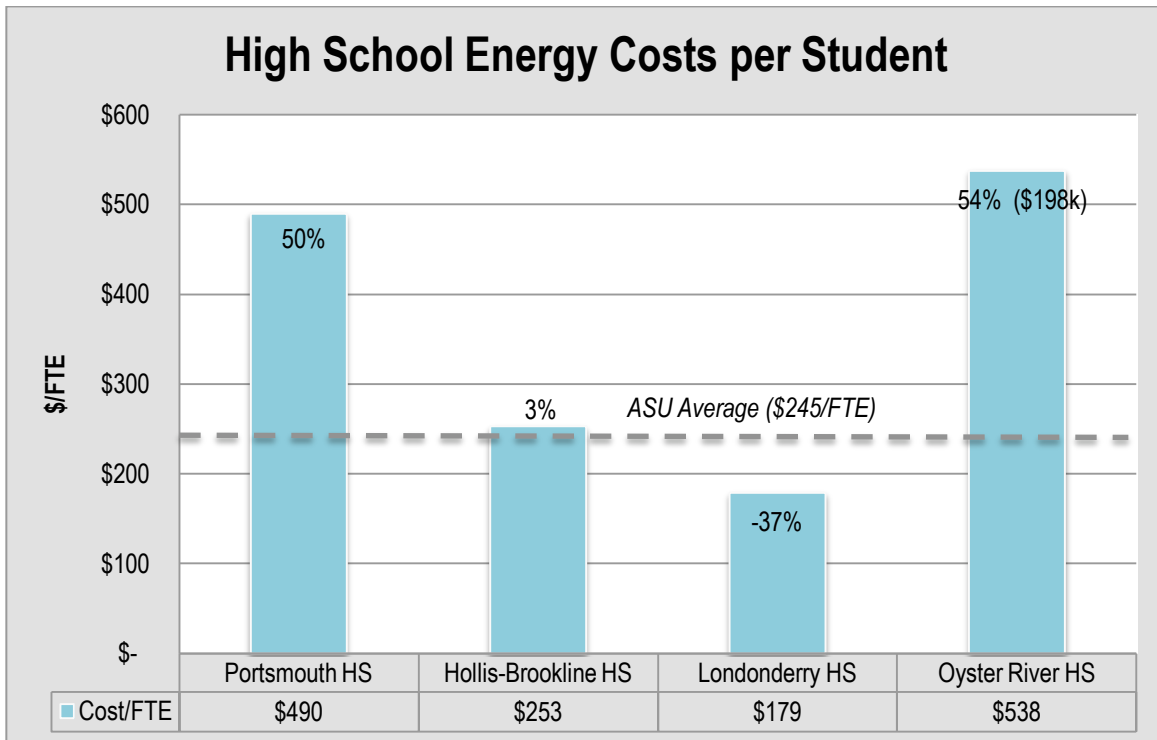
Figure 44 – High School Energy Costs per Student

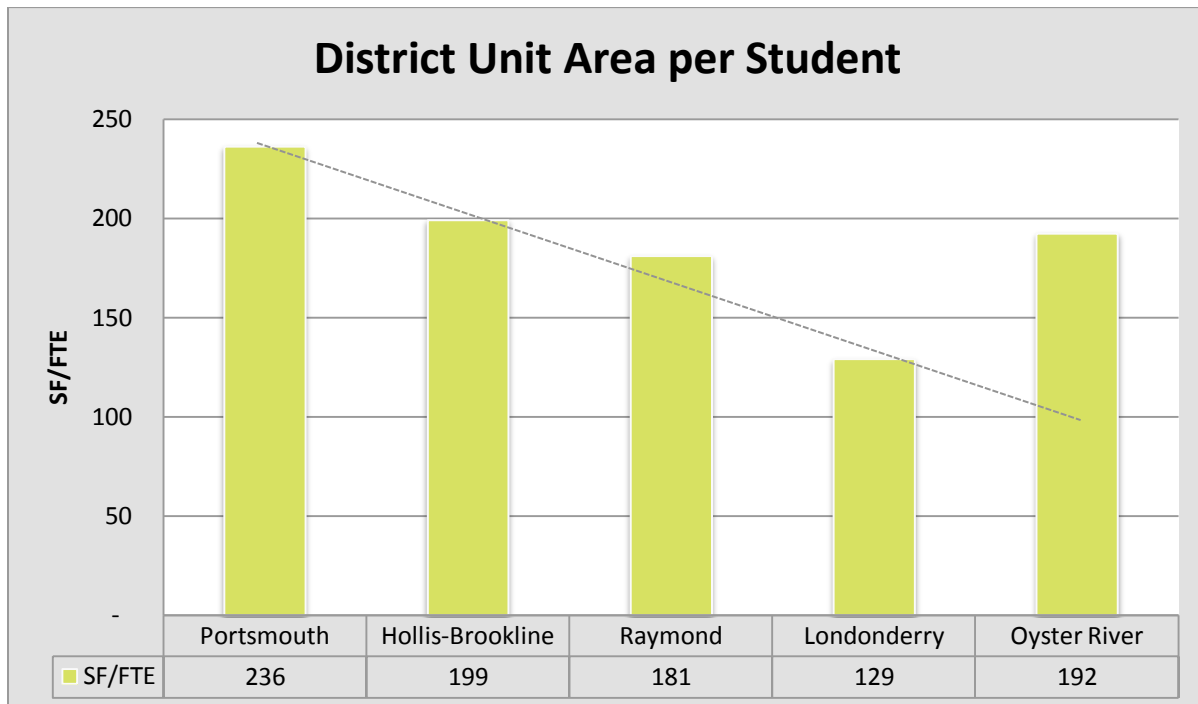
Figure 48 – District Unit Area per Student
