# OYSTER RIVER MIDDLE SCHOOL

## A FACILITY EVALUATION

### REGARDING ACADEMIC PROGRAMMING

May 2015

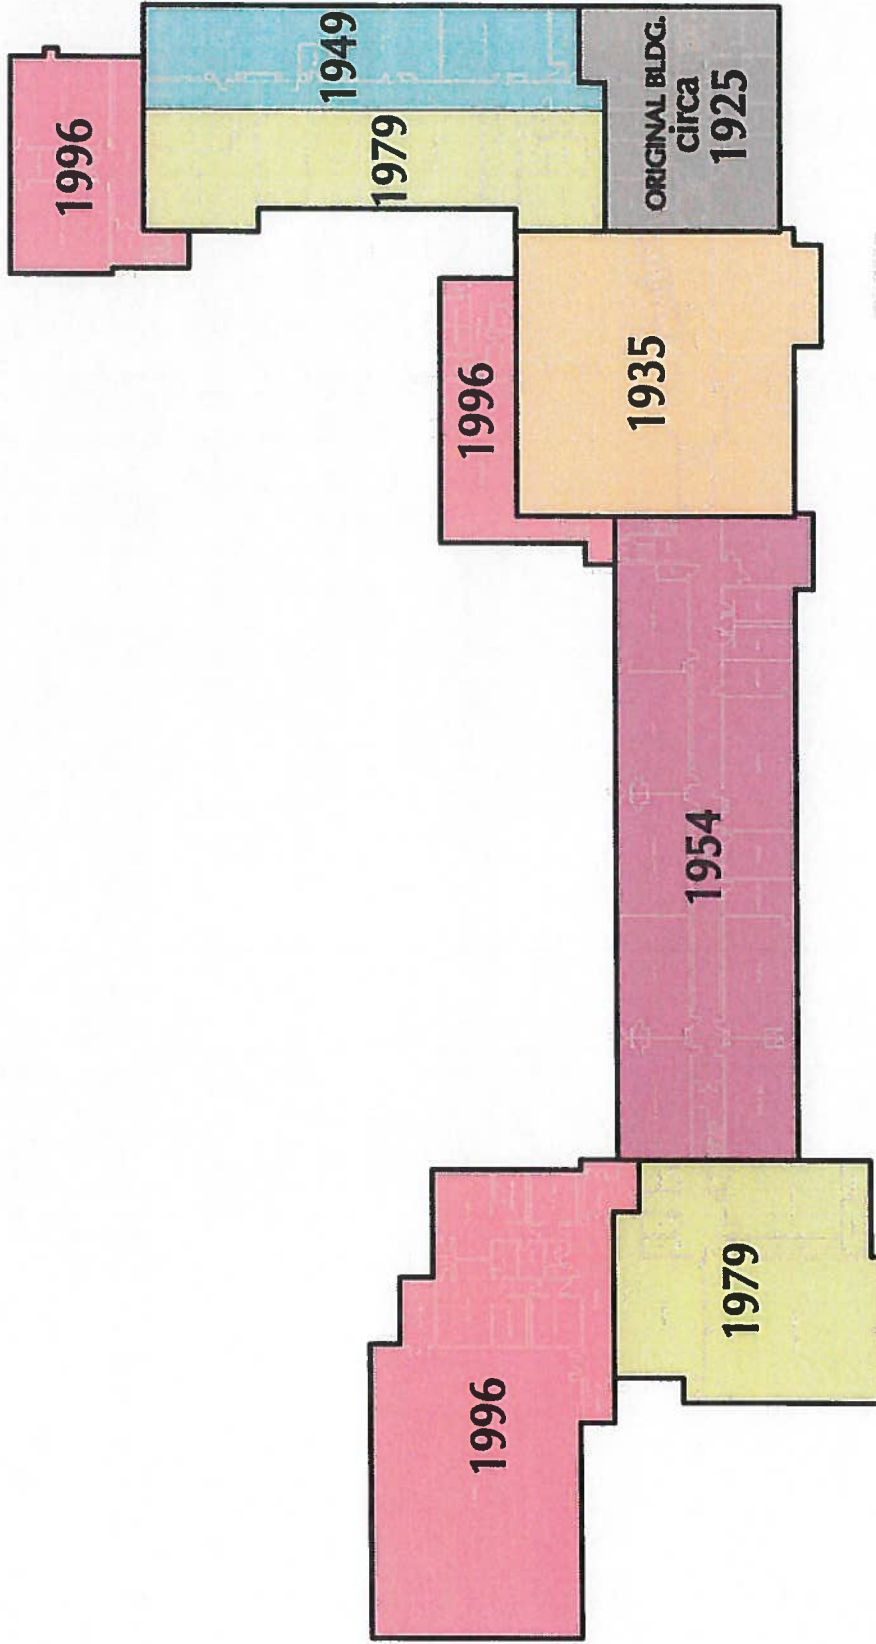
CONSTRUCTION TIMELINE  
OYSTER RIVER MIDDLE SCHOOL  
DURHAM, NH

- a. Numerous ad hoc additions have resulted in an inefficient layout
- b. Building infrastructure, systems and envelope are in poor condition
- c. Excessive mechanical system noise throughout
- d. Serious lack of storage
- e. Not designed for handicapped accessibility

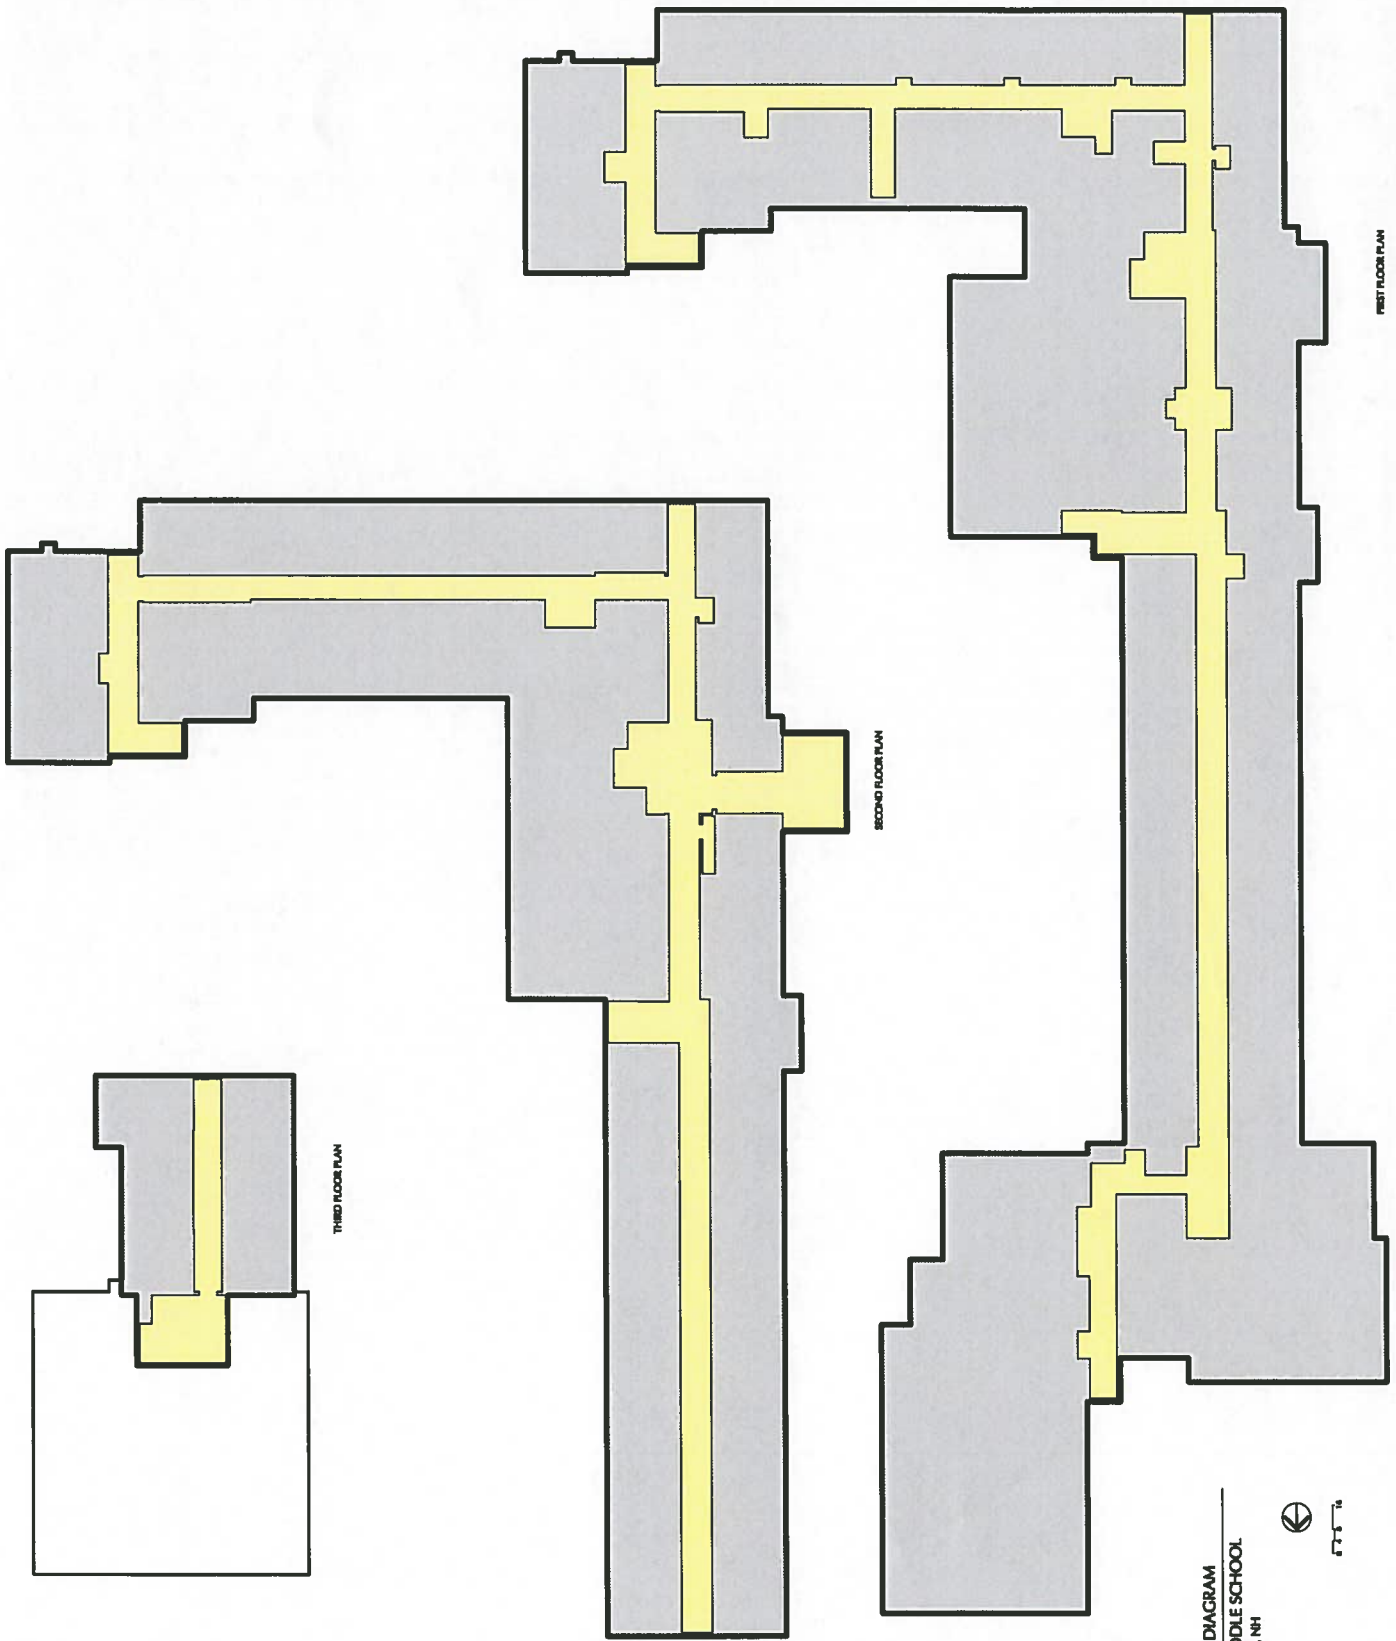
CIRCULATION DIAGRAM  
OYSTER RIVER MIDDLE SCHOOL  
DURHAM, NH

- a. Excessive travel time cuts into teaching time
- b. High corridor traffic distracting to adjacent classrooms
- c. Difficult to move large equipment & carts due to multiple level changes
