# OYSTER RIVER COOPERATIVE SCHOOL DISTRICT

## *Facilities & Program Analysis*

DAVIS GOUDREAU  
ARCHITECTS

# **FACILITY & PROGRAM ANALYSIS**

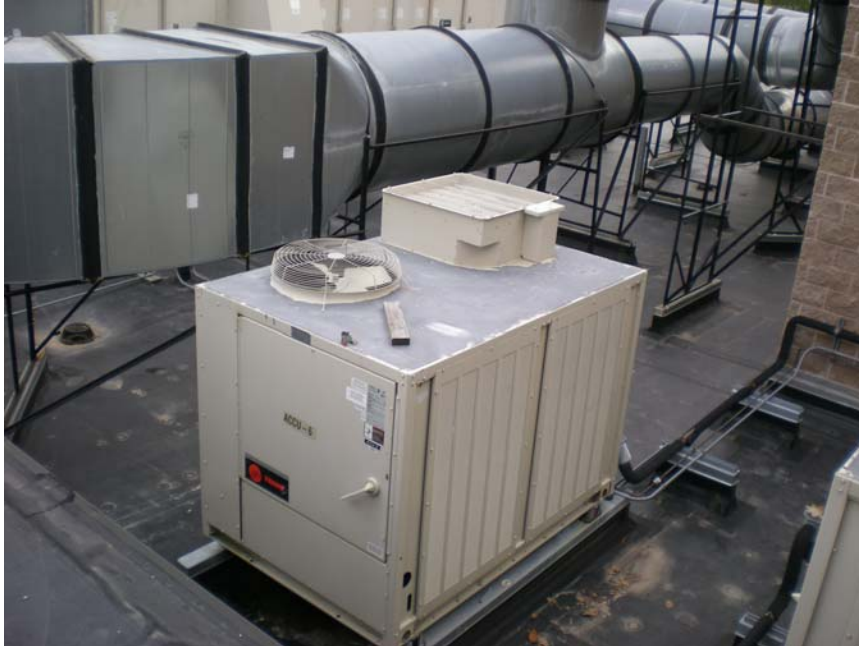
Typical Rooftop Condensing Unit for A/C

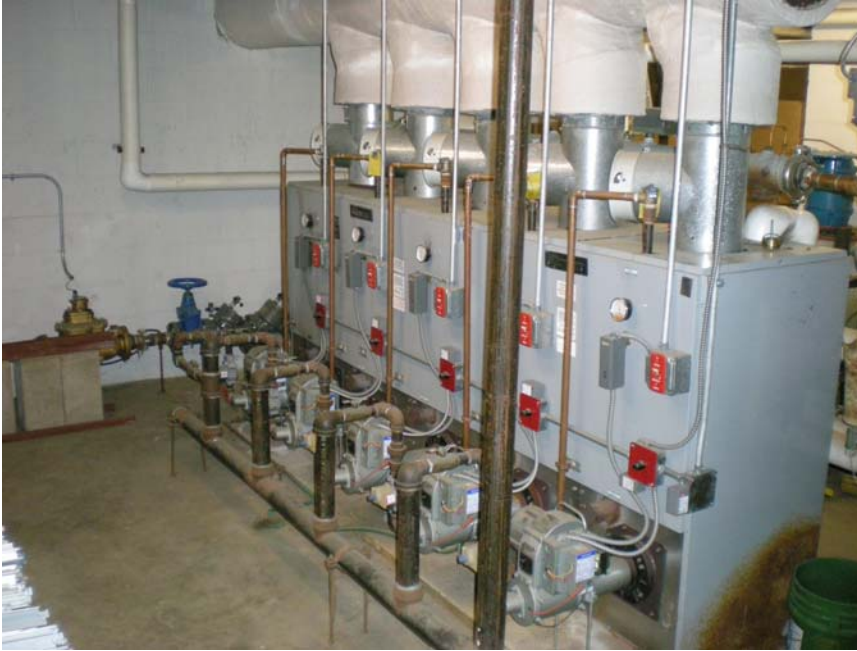
The first boiler plant is located in the basement of the south wing (east end – BOILER ROOM B03), installed in 1995. This plant consists of five cast iron boiler modules with a total output capacity of 1515 MBH (Hydrotherm Model MO-1925A). The boiler plant was originally oil-fired with a 79% Efficiency rating. Each boiler module has been converted to use a natural gas burner with an overall 77% Efficiency rating. Actual operating efficiency is likely considerably lower due to various factors, primarily related to the age and configuration of plant.

Heating Plant #1 – Modular cast iron boilers (1995 Installation)

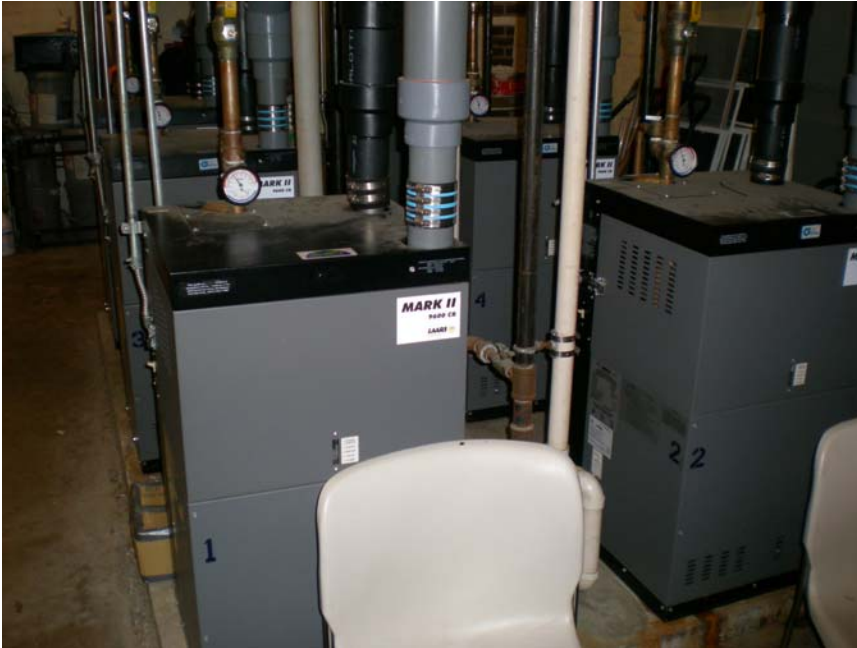
The second boiler plant is located centrally at the ground floor of the south wing, adjacent to the kitchen area (BOILER ROOM 109A). The location is above the original boiler plant location on an in-filled floor. This plant consists of six high efficiency condensing boilers with a total output capacity of 1350 MBH (Laars CB-M2-250N), installed in 2008. Each boiler has a rated efficiency of 89% and is capable of higher efficiencies at lower hot water operating temperatures (typically achieved by using an outdoor reset schedule to use lower hot water temperatures during warmer outdoor conditions).

Boiler Plant #2 – Modular Condensing Boilers (2008 Installation)

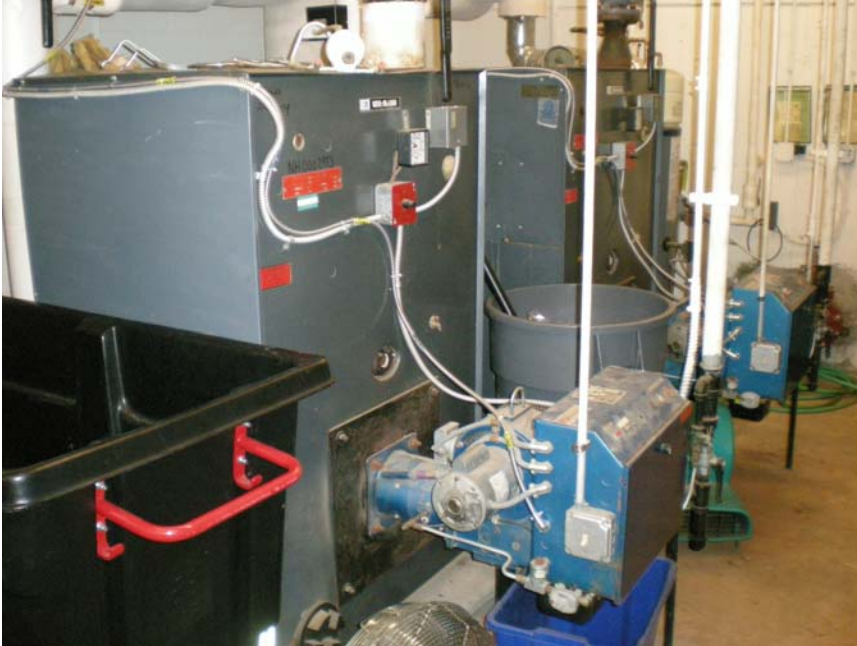
Cast Iron Boilers (1989 Installation)

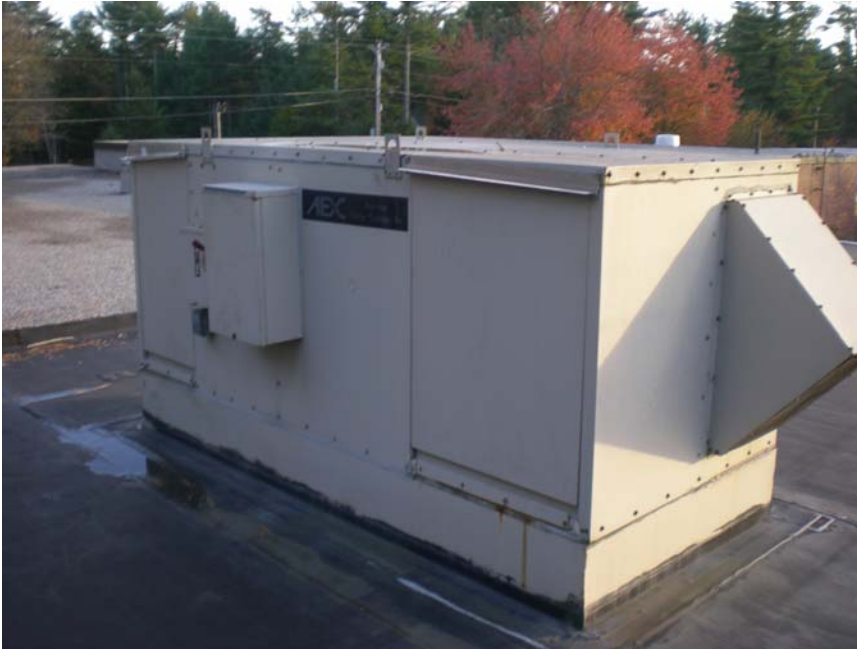
It appears that the exhaust grilles for Toilet Rooms #35 and #36 are not connected to the local ERV system serving the area (perhaps still connected to an abandoned exhaust fan on the roof).

Typical Rooftop Energy Recovery Ventilation Unit (1994 Installation)

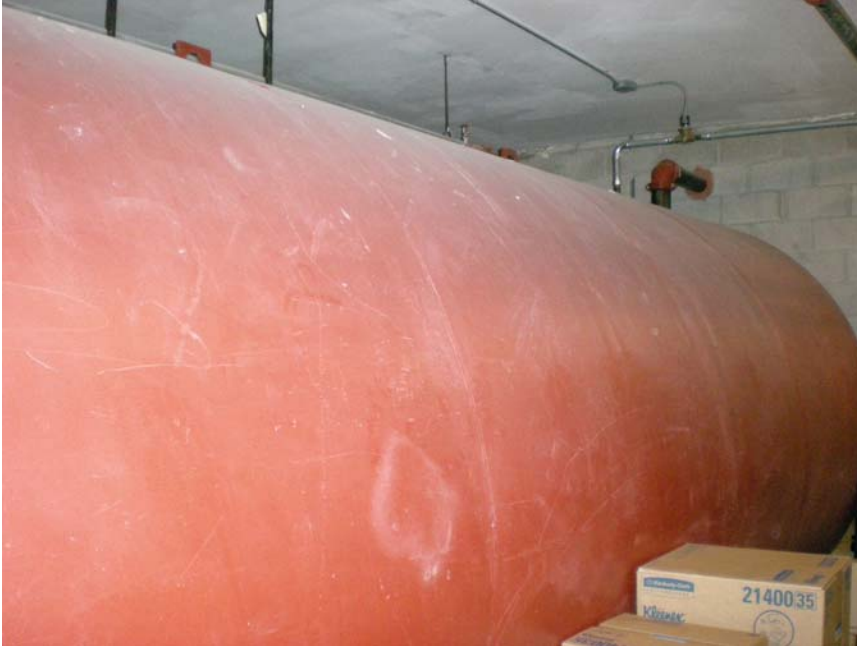
Approx. 5,000-gallon Fire Protection storage tank in shed
